Infrastructure News 7B points Part 2

The project to relay the critical 7B points at the south end of the platforms at Sheffield Park was, due to time constraints, split into two parts. Part I, during which the centre section of 7B points had its timbers replaced, was <u>reported here (November 2018)</u>. The report which follows, originally covering only the second and third days of Part 2, but has now been edited to include Jon Goff's earlier report covering the first day of the work. It thus covers all of Part 2 of the 7B relaying, as undertaken in a week in early March 2019, before the full weekday running season began.

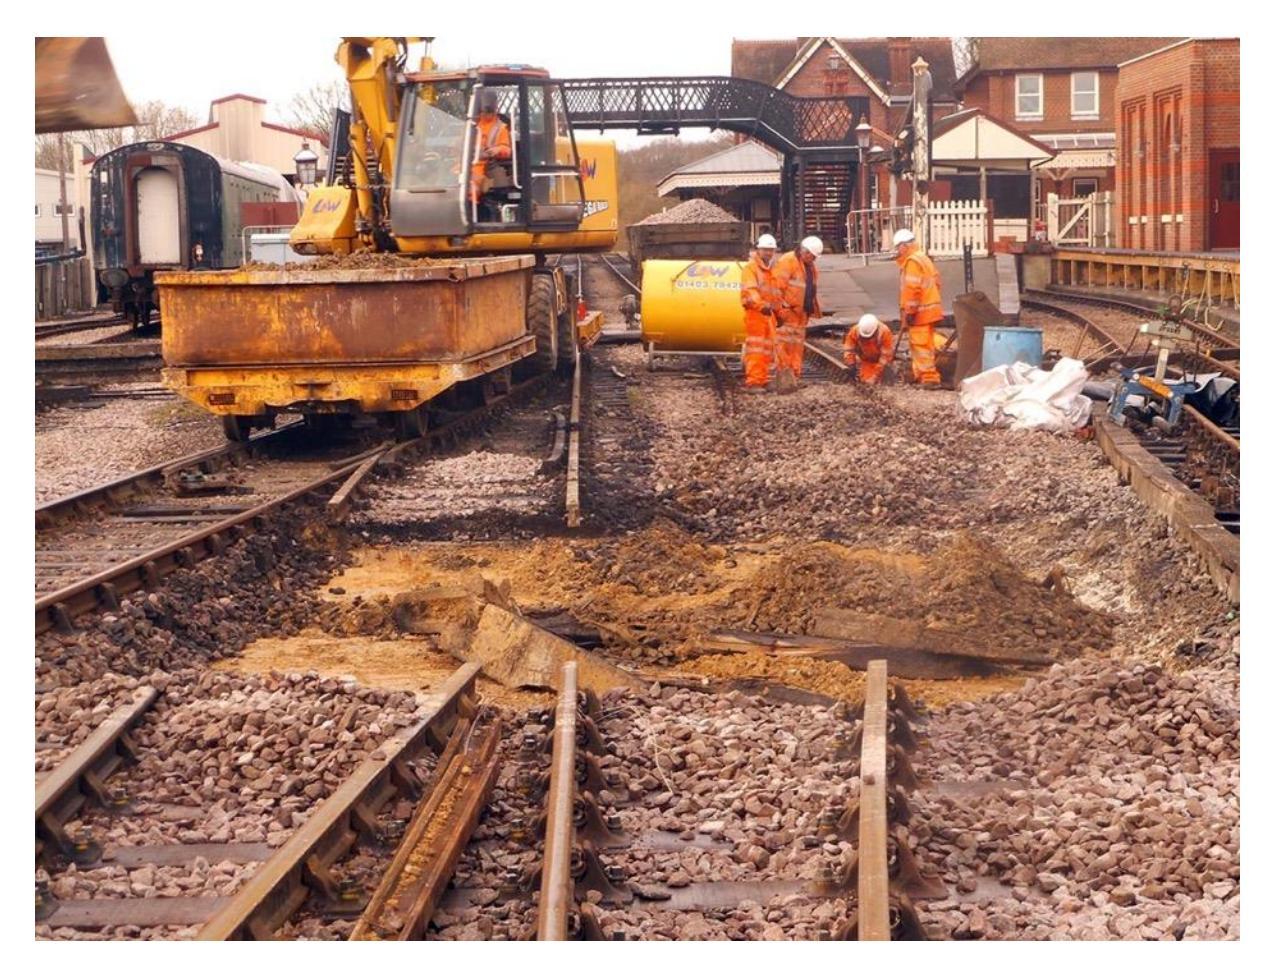
The old softwood timbers were life expired and so are the timbers under the crossing nose. Therefore we are correcting this before the full weekday running season begins. In addition to replacing life-expired timbers under the crossing nose, we lifted and put in drainage for the 60' panel from road I which has been slowly sinking into the mud. The pictures below show the progress at the end of the first day with the rails pulled out and the base under the crossing nose almost dug out. The first picture was taken standing on the section renewed in November.

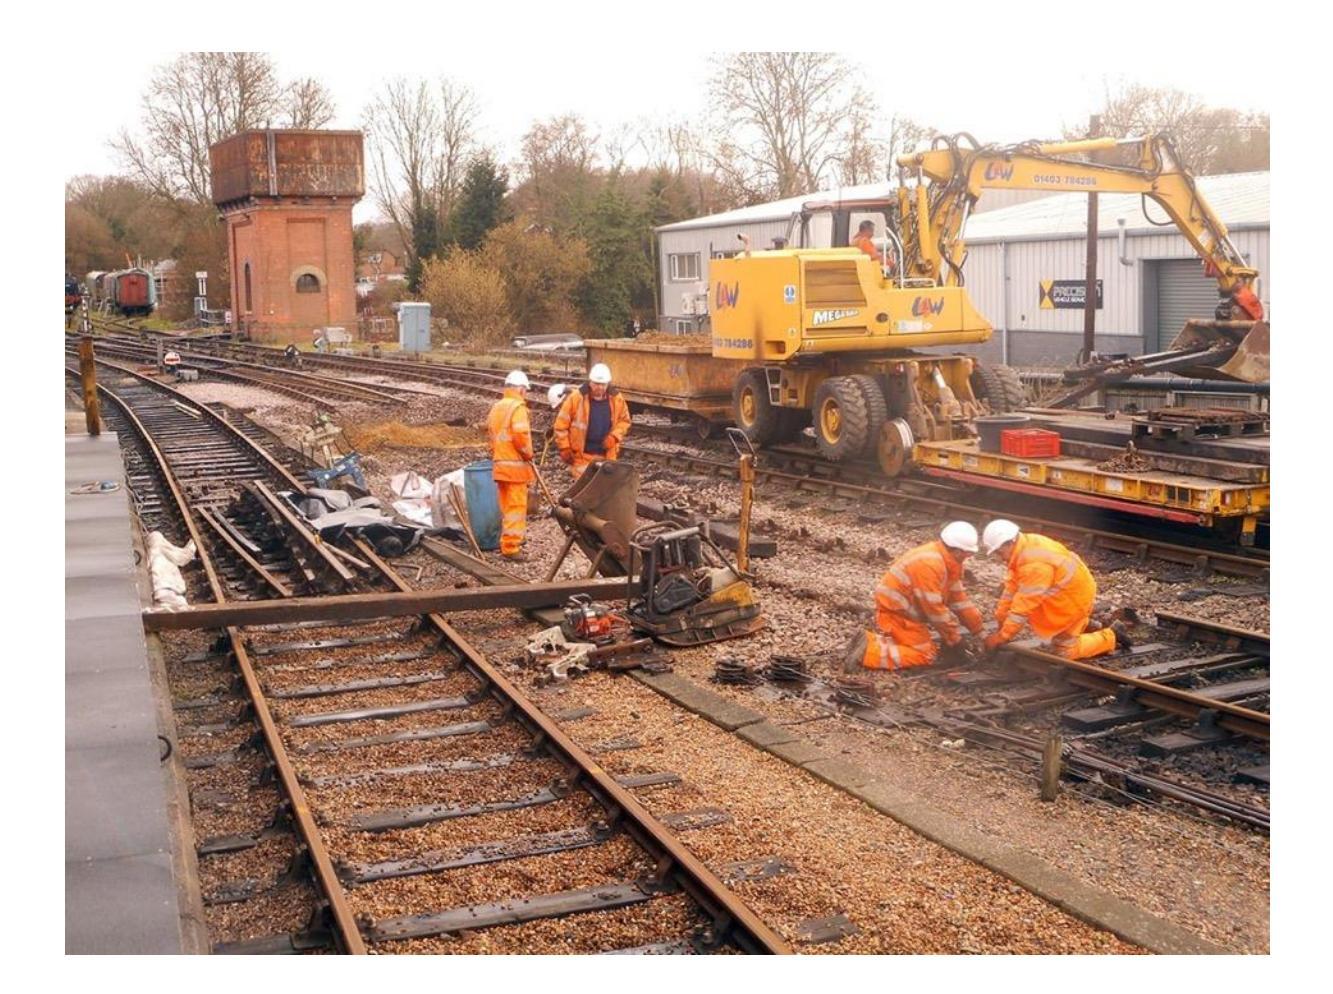
Unfortunately an old monument had to come out as two 20' long timbers that need to be replaced were sitting one on either side of it.

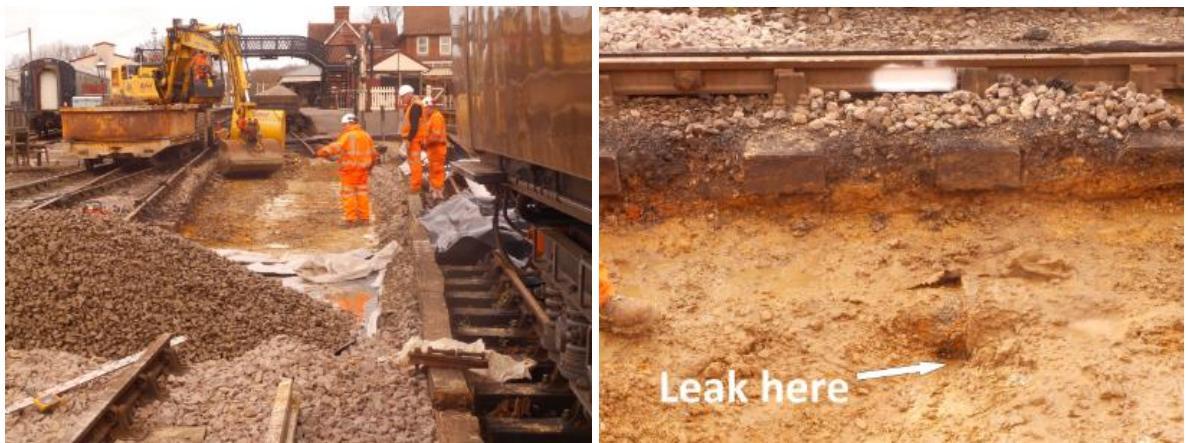
This piece of track keeps sinking into the mud and has had extra ballast and tamping carried out on it several times to keep it stable. Consequently a lot of reusable ballast was scraped off the top after the rails and sleepers had been removed. It was washed with the aid of the water crane and piled up where the crossing nose would be. The track bed was scraped down to the correct level carefully as the existence of the old cast iron pipe was known. One of the joints was found to be leaking which explains why this track bed is always wet. This joint is directly below the west rail with the sleeper did not have much clearance to the pipe as it had sunk so much.

Scraping out the ballast and mud.

Leaking pipe found and marked.

Luckily there is a drainage pipe running past already buried below the track bed, therefore a small drainage trench and pipe were installed it connecting to the leak to the remove the flowing water. The position was marked with a white spray on the adjacent rail. This has shown us the condition of the pipe and we now know that we will have to get a liner installed within the pipe in the near future. This picture also shows how little ballast is under the sleepers on the adjacent track. The sleepers are almost sitting on the bottom of the track bed where there should have been several inches of ballast on top the original chalk membrane. It therefore also show us another dig out task required in the not too distant future.

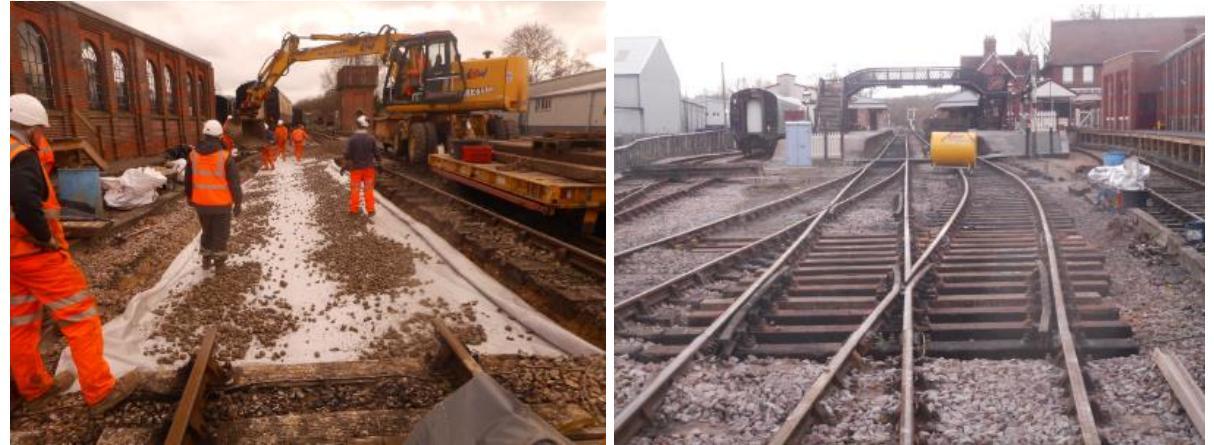
New modern membrane.

All connected by the end of day three.

All the exposed track bed was covered with our usual sandwich of Terram/plastic DPC/Terram to stop more water soaking into the ground. The washed ballast was spread out and more fresh ballast added up to bottom of sleeper level. It was smoothed and rolled down flat and all the sleepers for the 60' panel laid out. With a bit of **very** clever digger driving, the two bullhead rails were dropped straight in place within the rail chairs in seconds! This normally takes a lot of fiddling, especially on a curve. The panel was then finished off ready for the crossing panel.

The replacement timbers for the crossing were laid out including the 20' timbers which pass under the adjacent track and the rails placed on top. The assortment of fishplates were then put back so that the S&T could get all the track circuits and signal wires reconnected. This left is with over 100 hole to drill in the timbers for the chair screws after carefully aligning and gauging the rails correctly to within 1mm.
