Three Arch relay - end of week 2

Jon Goff's report covers the period 11-17 January 2020, the second week of the track relaying project through the very wet cutting at Three Arch (Nobles) Bridge. It follows on from the [reports from the first week, here](#).

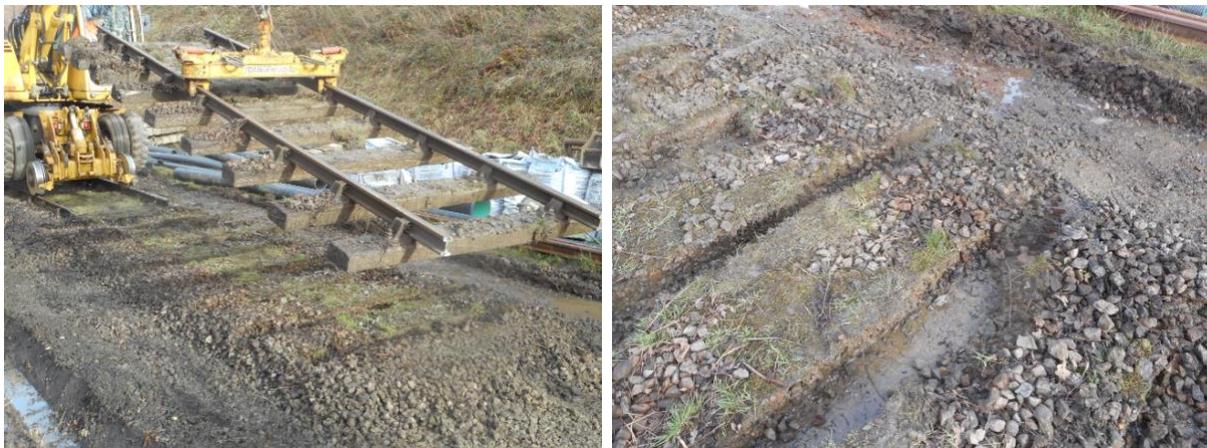
The first two pictures show the worst of the wet section being prepared where all the old ballast and mud mixture had to be completely dug out and removed. This area has been wet for such a long time that clay pumps up over the sleepers every time a train passes and bull rushes grow beside the line. We probably went down 8-10 inches below the bottom of the sleepers here and replaced it with reprocessed second hand ballast. Elsewhere we went down as little as only 2-3 inches as much of the ballast was reusable.

The reusable ballast was pushed over to the side to create some working space. The track bed was then covered with the Terram and plastic layer before putting the ballast back. More ballast will be added after the rails are reconnected and tamped up another 2 inches or so.

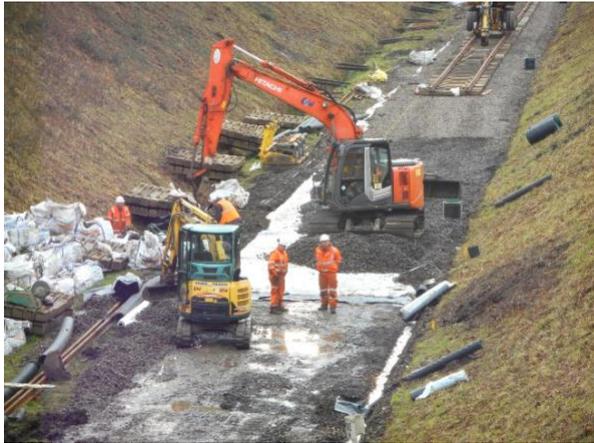
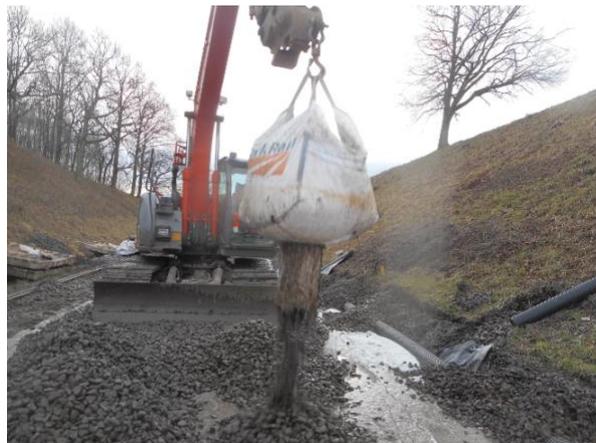
Garry and Andy can be seen here discussing the area and how to cut the next section of Terram and plastic for the wettest part. It is particularly bad in the picture as we had just had another sharp shower but in due course, it will dry out and harden under the plastic membrane. They are standing just off the previous section of membrane where Bob had just dropped some bagged ballast in place. The bags of ballast had been stacked to the side before the relay started as it would make getting ballast to this area much easier when the track had been removed.

At the bottom of the picture the 10 ¼ mile post can just be seen, and immediately above it, an extra piece of plastic was placed there to catch the water from the natural spring in the cutting side and guide it into the drainage ditch. In the next picture one of these bags is being emptied by releasing the tie that holds the hole in the bottom closed. Again, this is right next to the spring in the cutting side.

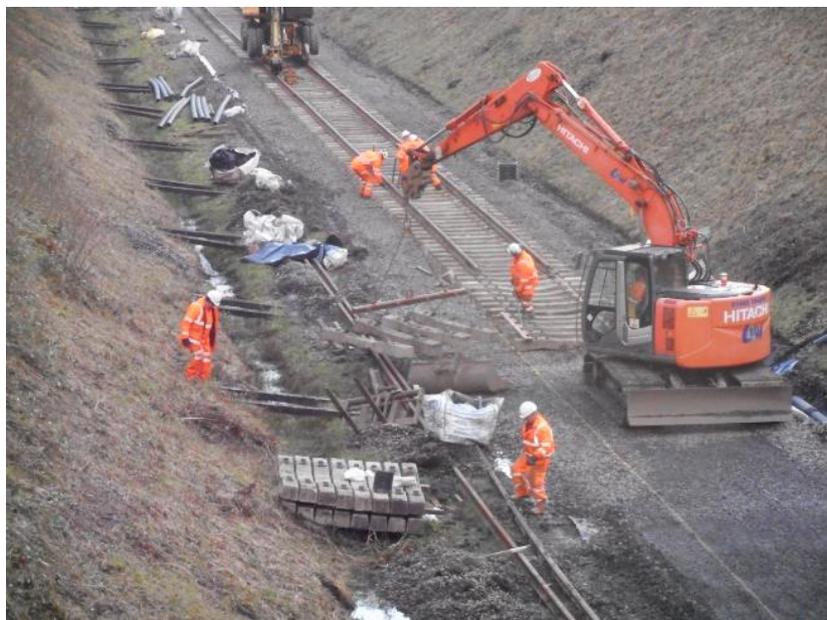
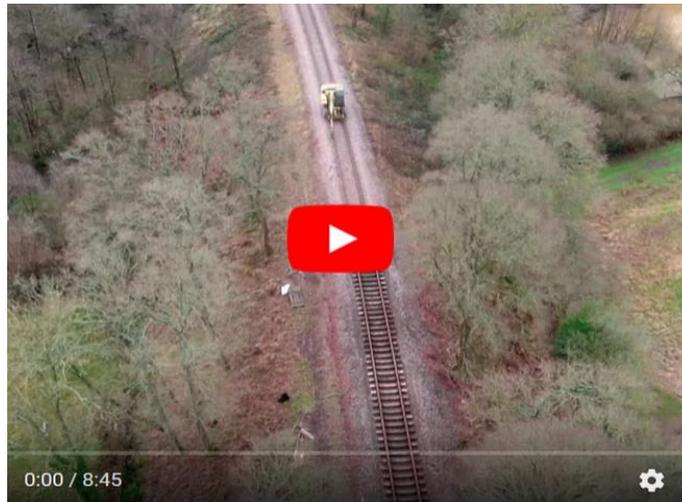
After bulldozing the ballast flat and compacting it smooth with the triple Wacker, the yellow line was painted on the ballast in line with the sleeper ends to help the team to place the sleepers accurately, as seen being craned in four at a time suspended from a lifting bar. These are placed with their centres on average 653.27mm apart!! But normally within 5mm of that giving 28 sleepers per panel instead of 24 as was the previous standard.

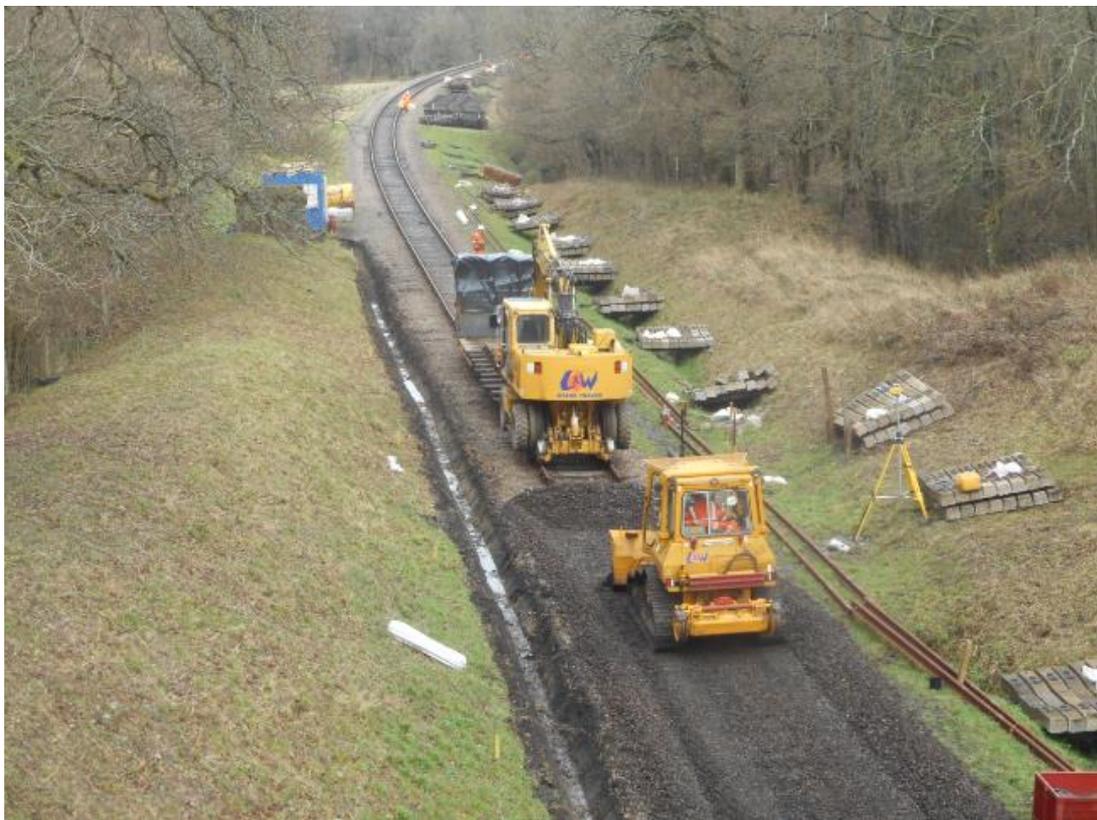
The preparation of the track bed north of Three Arch Bridge at the end of the second week can be seen in the photo taken from the top the bridge. The northern end of the job is to be just before the piles of removed track panels in the distance. The bulldozer is pushing back some of the reusable ballast and is almost up to the point where the membrane will finish. The new second ditch is complete and ready for the drainage pipe. The laser is set up on the tripod to the right and angled to the correct gradient of the line. The two laser receivers on the dozer can be seen sitting on top of the masts at the front. The other important item in the photo is the blue cabin; our temporary lobby where the kettle resides!

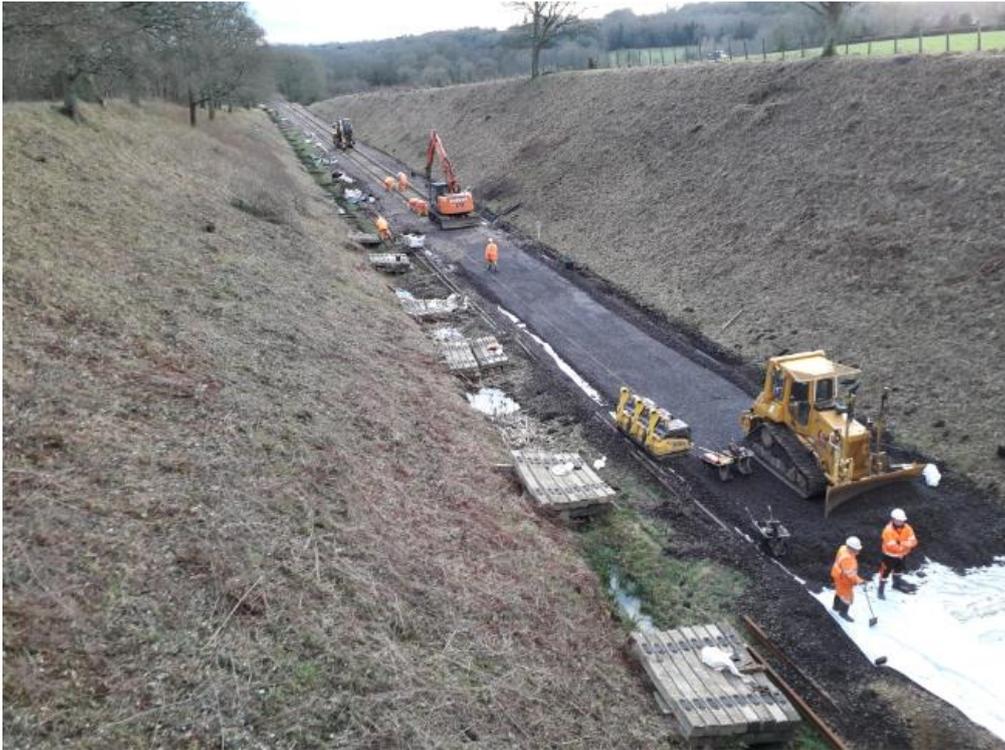
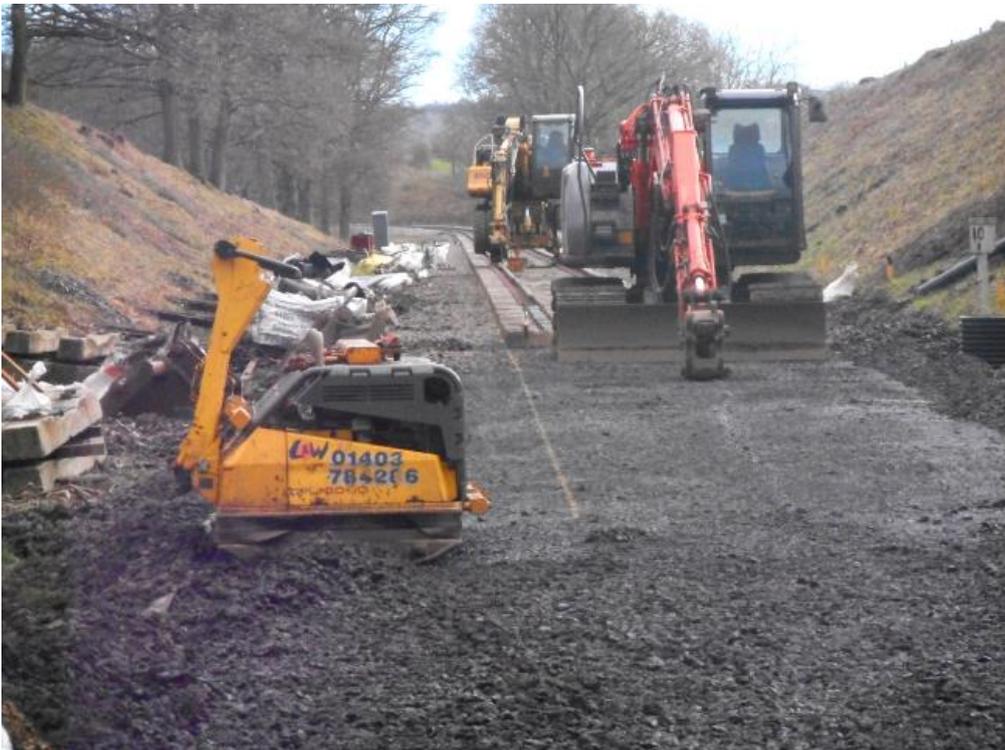
Finally, two pictures show how we left it at the end of Friday, one from the top of the bridge just before we stopped putting out sleepers and one looking back along the line from under the bridge. The straightness was due to the use of our new (gifted) theodolite which we are very pleased with and the smoothness is due to the use of our laser with the laser bulldozer. This makes tamping a lot easier as is as good as main line standards.
