Maunsell Locomotive Society

Q CLASS NO 541

V CLASS NO. 928 STOWE

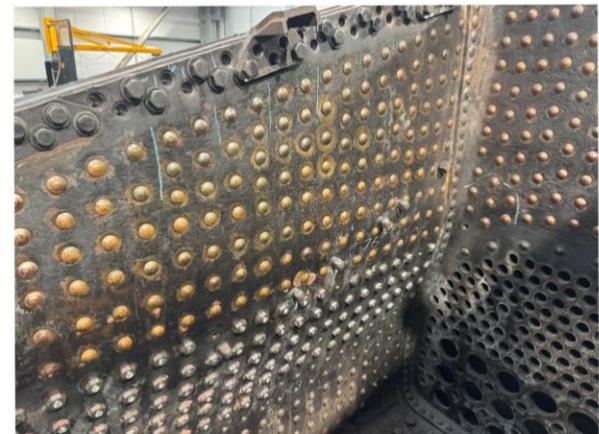
Top: A view of the inner firebox, showing the new copper stays and new monel stays with their stay nuts fitted.

Work on the boiler has progressed steadily, largely focusing on annealing, setting, fitting and heading over the copper stays. Work to caulk and nut the monel stays has also been largely completed. Some of the smaller and more fiddly jobs like repairing and fitting the mudhole doors, marking out and fitting the blowdown valve and reaming foundation ring holes have started. These are all essential but more time-consuming tasks.

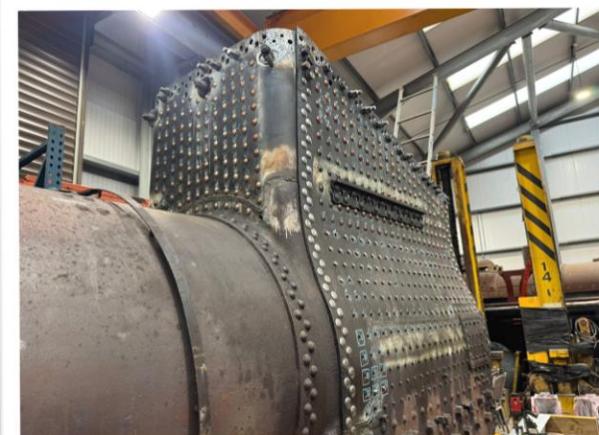
Bottom: A view of the outer firebox, showing the new patch screws, copper stays and monel stays.

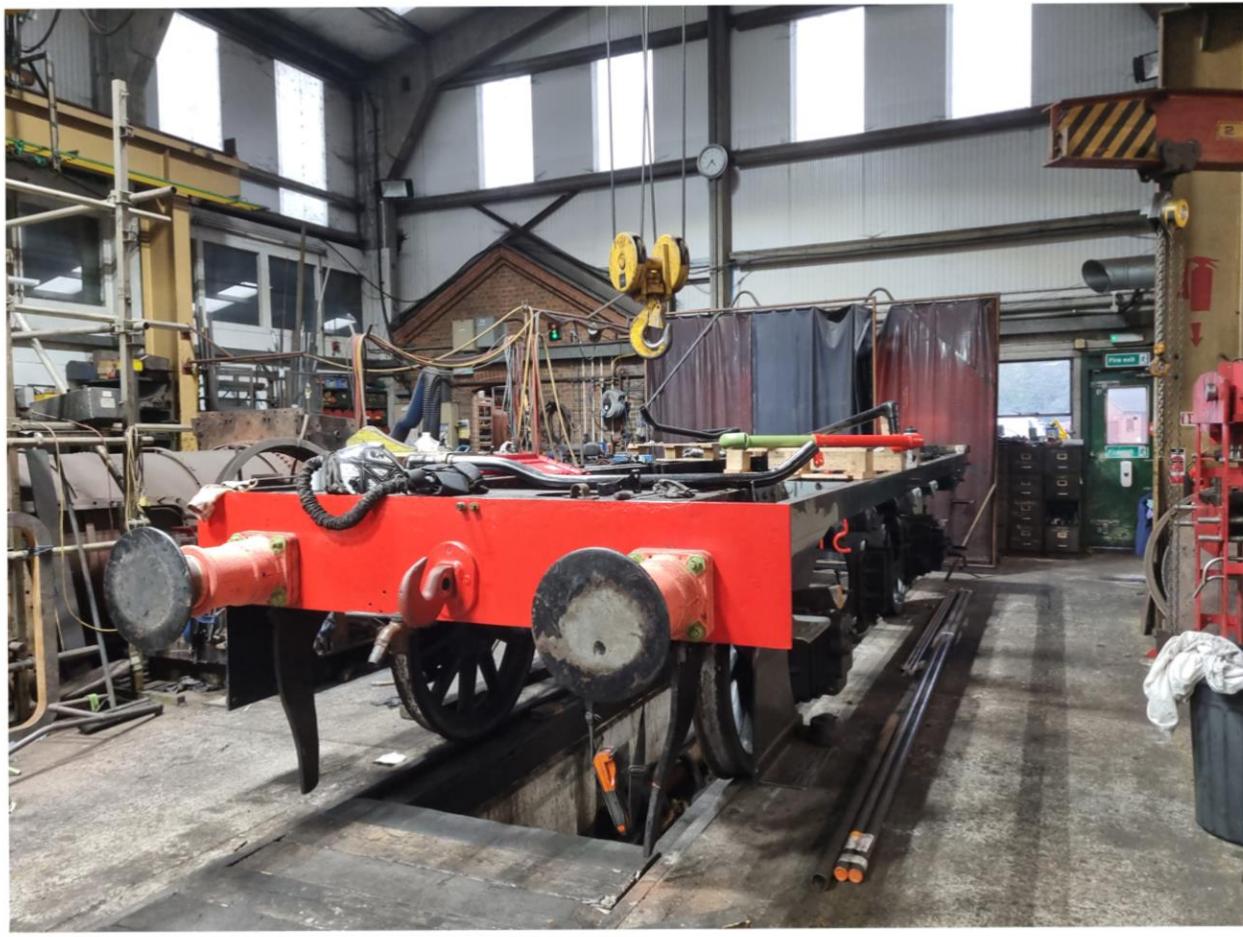
Buffers back up on 541's tender chassis. Photo: Steve Pilcher

Back at Sheffield Park, work on repairing and machining the various fittings continues as well as work to the tender tank and chassis. In particular, some of the workshop volunteers have been busy painting the tender chassis pipework and getting the buffers back up into place. The MLS working party have concluded cleaning the interior of the
