# 84030 Rebuild Project

By Chris Wren

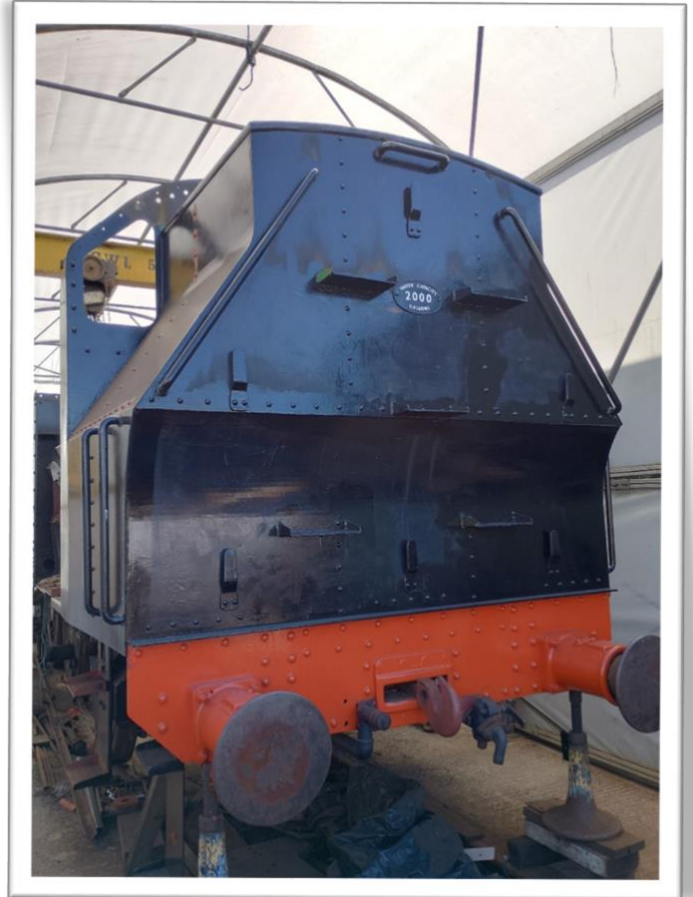
**Above:** Bunker with all lamp brackets and steps plus a coat of paint to the bunker back panel and buffer beam

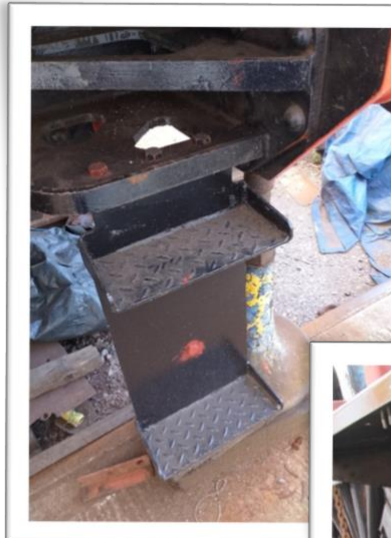
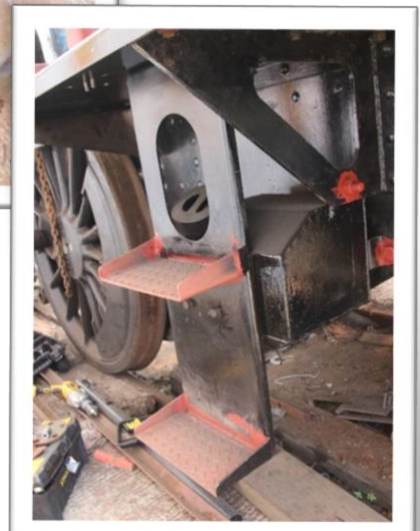
**Above and right:** Bunker (above) and cab (right) steps in their final positions

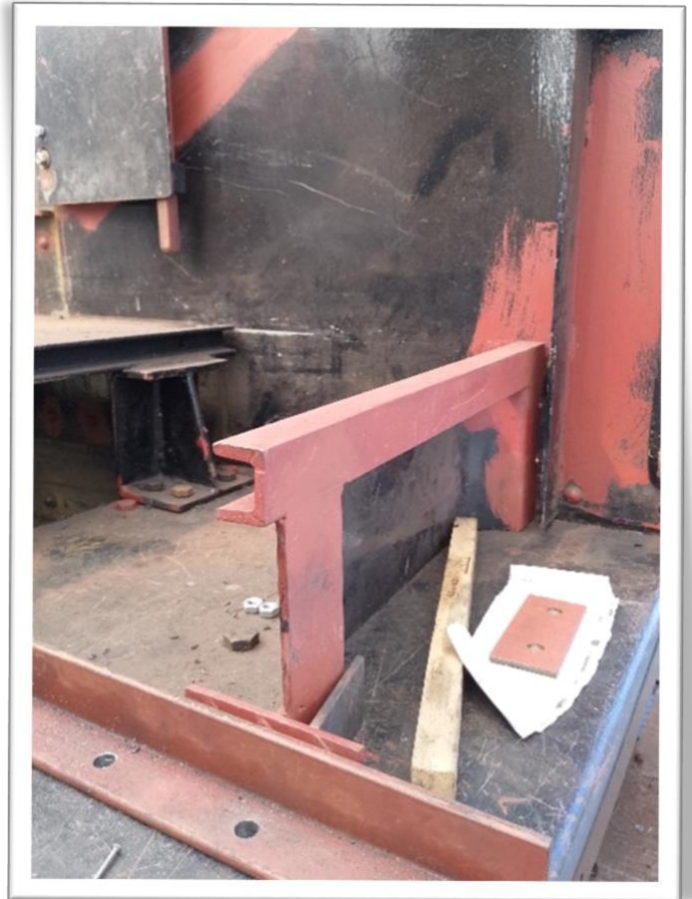
**Right:** Cab floor supports under construction and shovelling plate in final position

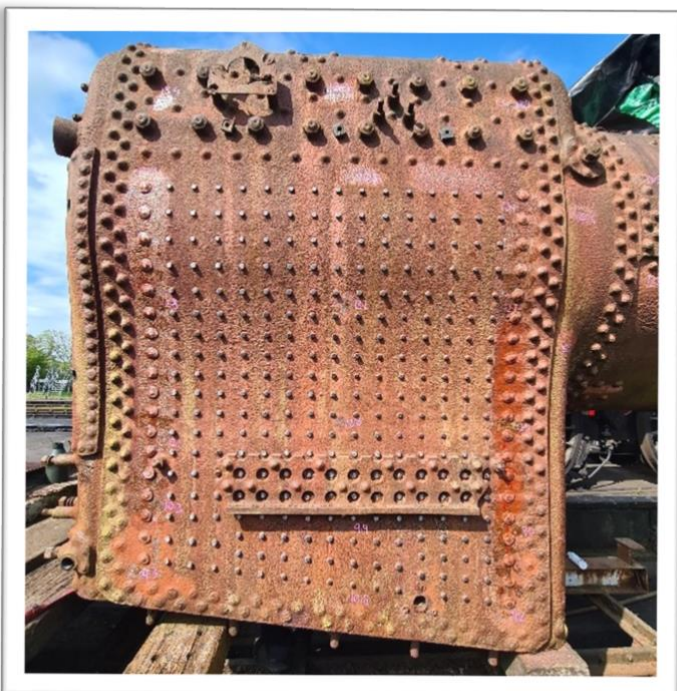
The result was encouraging, the test revealing thinning of the firebox lower outer casing, which was expected, and a known weak spot on the head of the boiler showed some cracks. The cracks were by the side of the strength shoulder plates on each corner of the boiler.

**Below:** The boiler at Sheffield Park

We are advised that neither issue is a major problem and both can be rectified with a new

outer plate on the lower section of the firebox and the cracks welded.
