Atlantic House WORK IN PROGRESS Autumn 2025

Once again the time has come to provide an update on progress with *Normandy*, the Adams B4 class 0-4-0 Tank locomotive.

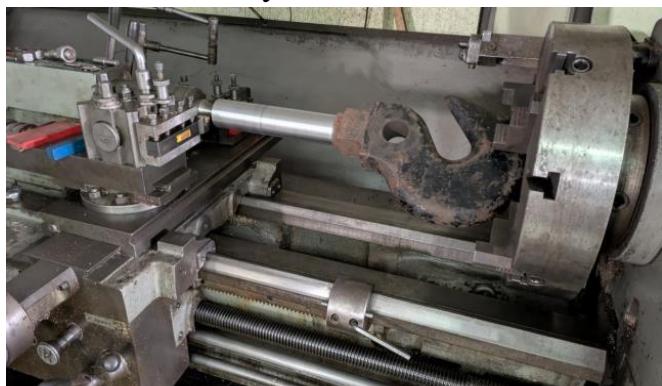
Fig 1. Shortened coupling hook ready for screw cutting

To start with, we found the rear coupling hook was worn down to an excessive amount and was in such a condition that it needed replacing. Building up with weld is a procedure that is totally unacceptable on such a stressed and safety critical component but a rummage in our storage came out with one that was in virtually new condition, but was about 3 feet longer than we needed. Our horizontal band saw sorted that bit, out but then it needed threading to take the retaining nut, plus the square shank was a little too large. It was mounted in the lathe and Malcolm carefully screw-cut the thread. After that he also made a new nut to suit. (Fig 1 & 2).

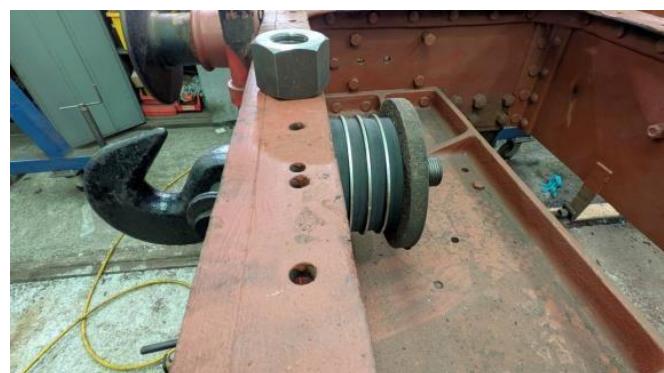
Fig 2. Reworked coupling hook being trial fitted.
The new nut can be seen on top of the framing

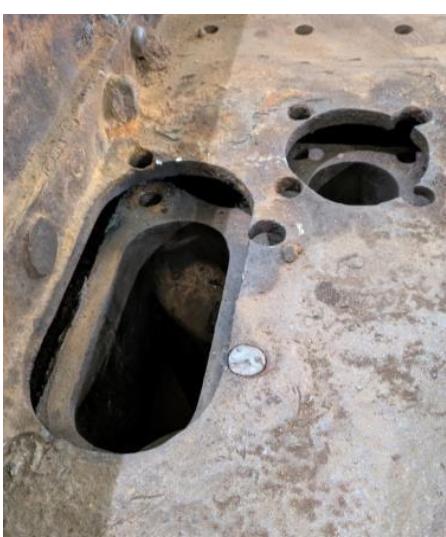
Fig 3. the plate over laying the valve chests. The cut off stud near the front shows the problem. These studs are firmly rusted into their threaded holes.

At this time, while the chassis was still on its wheels the cut off studs that were used to hold the main steam pipes and also the exhaust pipes to the valve chests were tackled. Keith Sturt's many years of experience together with bucket loads of perseverance and patience allowed him to remove all of these studs without damaging the threads in the cylinders. The holes in the valve chests into which those studs were screwed resides underneath the bottom plate of the smokebox, about 1½" above the valve chest casting. (See Fig 3).

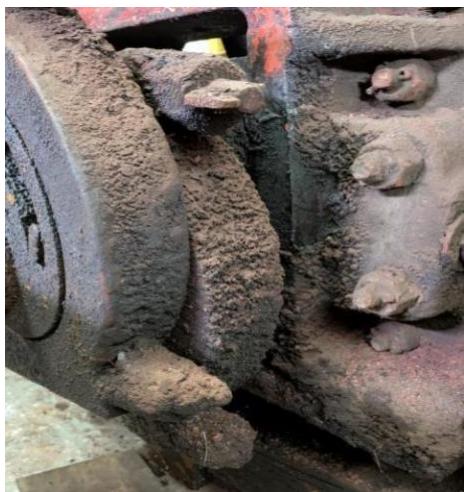
Fig 4. This shows the two right hand eccentric straps with the horn behind that is bolted to the frames.

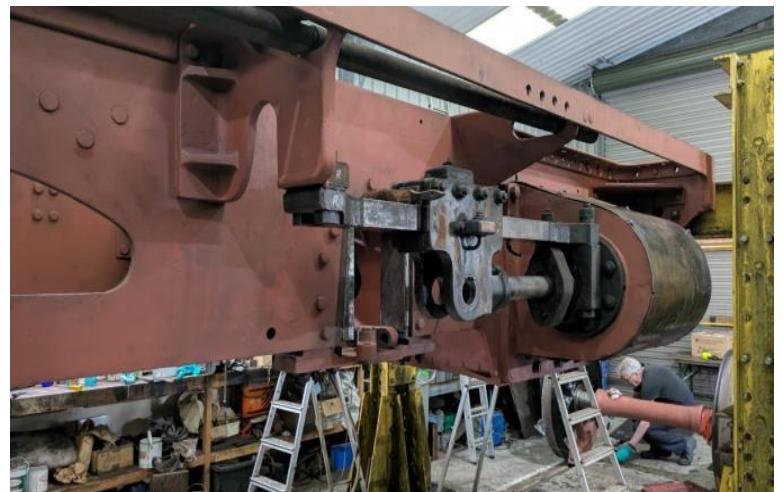
Fig 5. The frames now cleaned, needle gunned and in primer.

A major part of the work at this stage is removing great thick coverings of congealed grease, oil, ash and coal dust mix off of all of the parts prior to finding what fastenings one was dealing with. The whole of the mainframes were also similarly covered, often requiring burning or melting off before finishing by scraping and finally needle gunning. All of the frames both

inside and out have now been needle gunned and painted in red oxide primer. As before the great majority of the work in dis-assembling, and needle gunning has been carried out by Melvyn Frohnsdorff. (See Fig4 & 5)

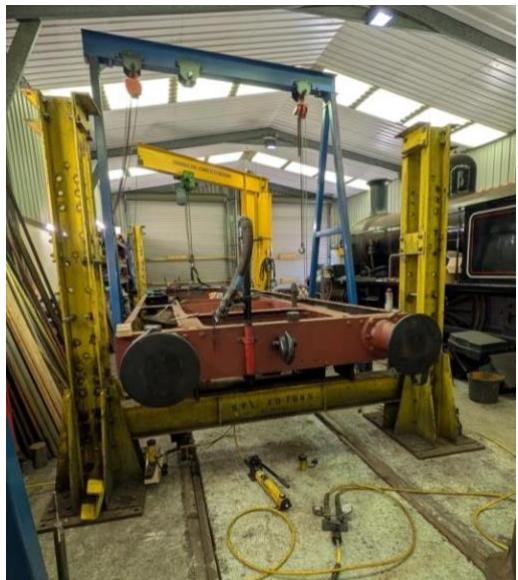
Fig 6. The lifting beams in place under the frames ready for lifting.

The lifting frames made for the Atlantic were renovated where necessary. So once we had finished with the chassis on its wheels the time came to lift it leaving the wheels on the ground. (See Fig 6)

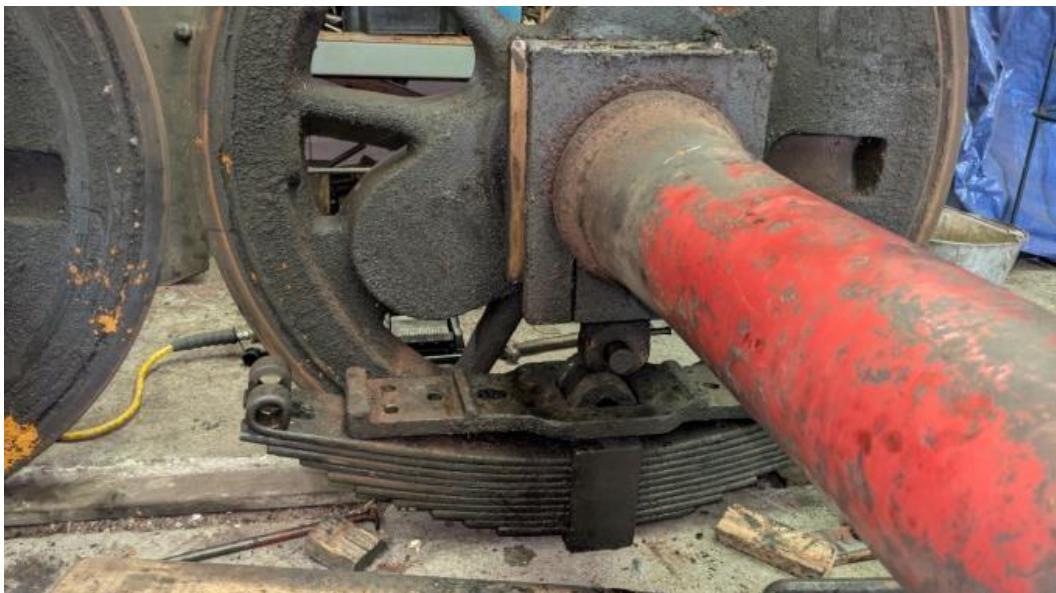
Fig 7. The horn stay on top of the spring and the axle passing through the axlebox.

Getting to this stage though took a lot of effort as most of the taper pins and the spring suspension pins were firmly held in place by corrosion and lots of various contaminants mentioned above. Again lots of heat from the oxy acetylene torch was required to loosen most of these parts followed by drifting out the part with suitable sizes of punch. (See Fig 7)

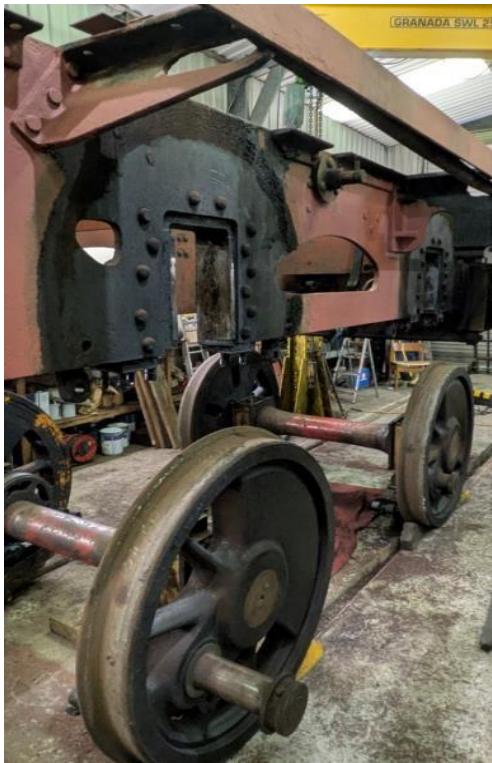
Fig 8. The frames now lifted, the wheels still on the rails. Note the dirt behind the area previously made inaccessible by the wheels.

Once all the springs had been lowered off of the hangers and the horn stays removed we could raise the chassis using the lifting frames and leave the wheels with their axleboxes on the rails. At this time we could really see the state of filth that the wheels and axleboxes were in and of course likewise the frame faces behind them. (See Fig 8).

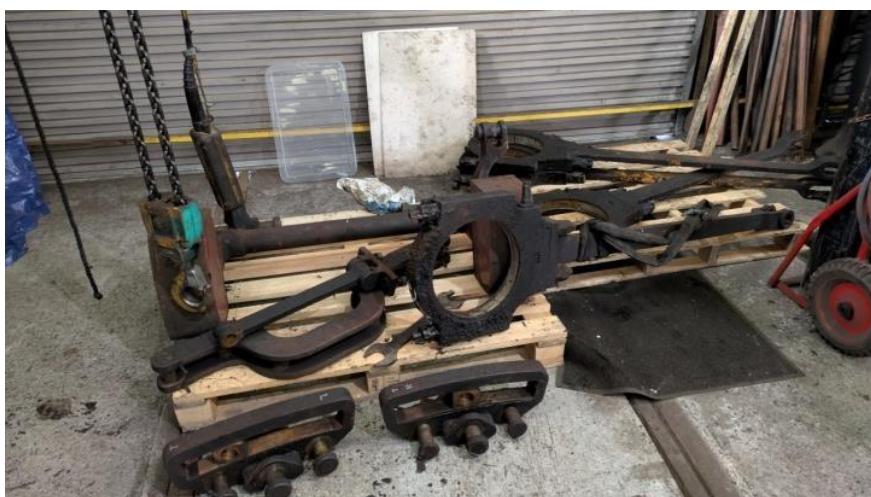
Fig 9. Valve gear parts removed, in the foreground the expansion links, the omega shaped part is an intermediate valve rod that dodges over the leading axle, and eccentric straps and rods behind.

A review of some of the valve gear parts and their condition, which in general was not too bad with some exceptions showed the eccentrics sheaves when compared dimensionally with the eccentrics on the axle were useable as they are. The clearances are within tolerance and wear relatively light and once again though cleaning was necessary. (See Fig 9 and Fig10).

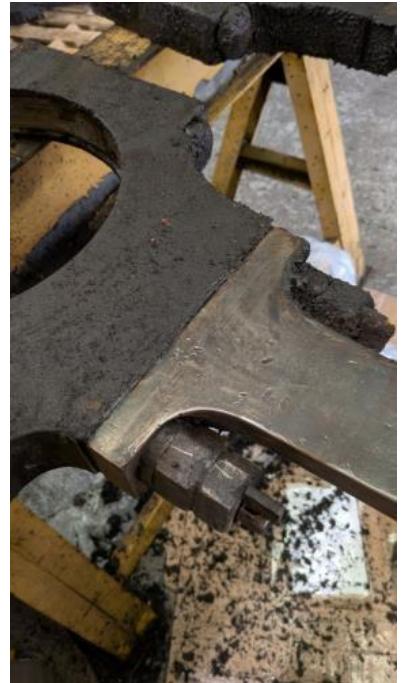
Fig 10 To the left is the dirty eccentric strap as removed and, on the right, the cleaned version.

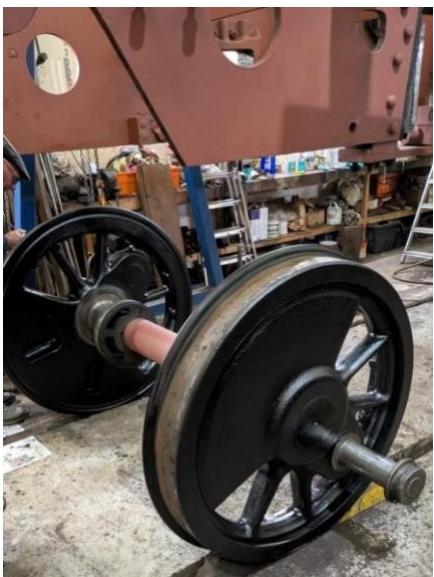
Fig 11. The cleaned wheels in black undercoat.

Once the frames were up in the air, then access was improved for needle gunning all the parts inaccessible before and the driving wheels could be rolled out and cleaned and then painted in primer and two coats of undercoat. (See Fig 11)

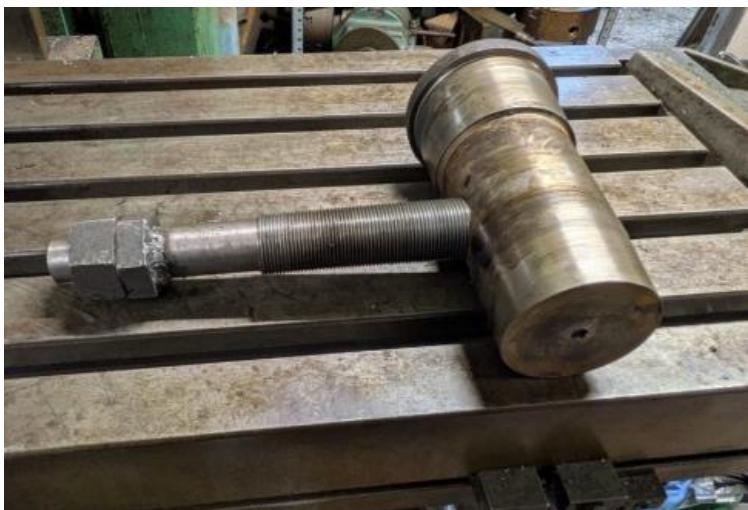
Fig 12. The dummy gudgeon pin with the fine pitched screw used to apply pressure onto the piston rod.

splitter, so again something new had to be made. A dummy gudgeon pin was machined from good quality steel, a hole was drilled then bored prior to tapping a hole right through it. We decided on 7/8" BSP as being a good size but with a fine enough thread yet robust enough to take a screw that will be tightened to its limit (or ours to be truthful!). (See Fig 12).

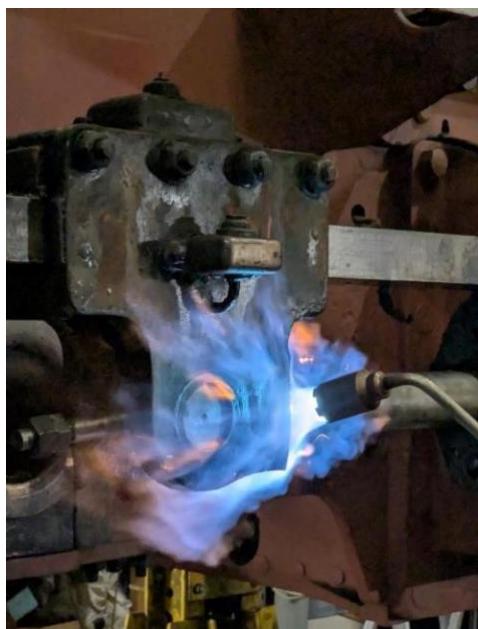
Fig 13. The crosshead here is being heated to expand it while force was being applied to the piston rod.

The dummy gudgeon pin fits through the crosshead replacing the original one, then the screw is threaded through it. The front end of the screw has a centre drilled hole in it as has the piston rod. When nearly in contact a hardened steel ball is positioned so in both the centre drilled holes in the screw and piston rod. The idea is that the ball helps prevent the end of the screw expanding under the pressure being exerted on it by the over tightening. Even with a length of pipe over a spanner no sign of splitting occurred so while under load the part of the crosshead with the piston rod taper in it was heated as quickly as possible using a large oxy propane torch. The crosshead should then expand slightly and its grip removed, and this is what happened to both sides. (See Fig 13 & 14).

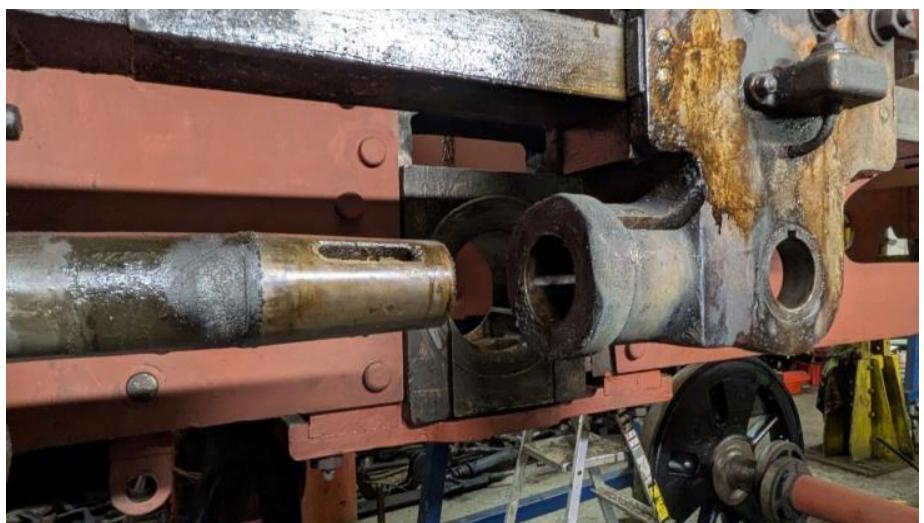
Fig 14. Here you can see the taper on the piston rod that fits into a matching one in the crosshead. Also the slots in both items that take the key that retain the parts in case of shock loadings such as water trapped in the cylinders.

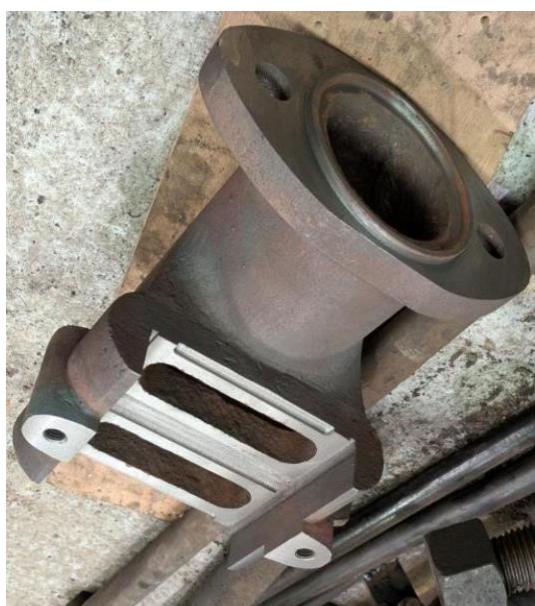
Fig 15. Here is the re-machined regulator body. When will this be installed!

Just to prove something productive has happened here is a photograph of the original regulator casting now fully re-machined in our main works, ready for installation-- eventually! (See Fig 15)
