# BULLEID SOCIETY

### *No. 96 Normandy*

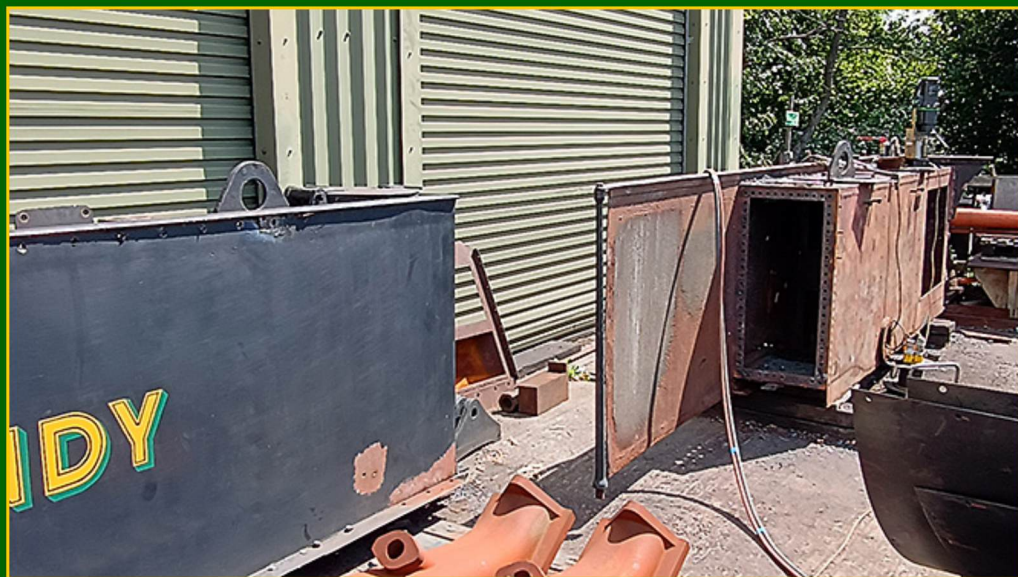
Work has now started to replace the platework on the two side tanks where corrosion has occurred. The junction of the top of the tank with its vertical outside face is covered with beading of unusual profile, which is being carefully removed from the original tanks for reuse. Fittings on the tender tank tops are being removed, cleaned, painted and put into storage for reinstatement on the new tank tops. Much of the 1893 vintage tank platework is of riveted construction – welding was in its infancy when No 96 was built in 1893 – but where not visible replacement materials will be welded.

*Normandy's side tanks.*

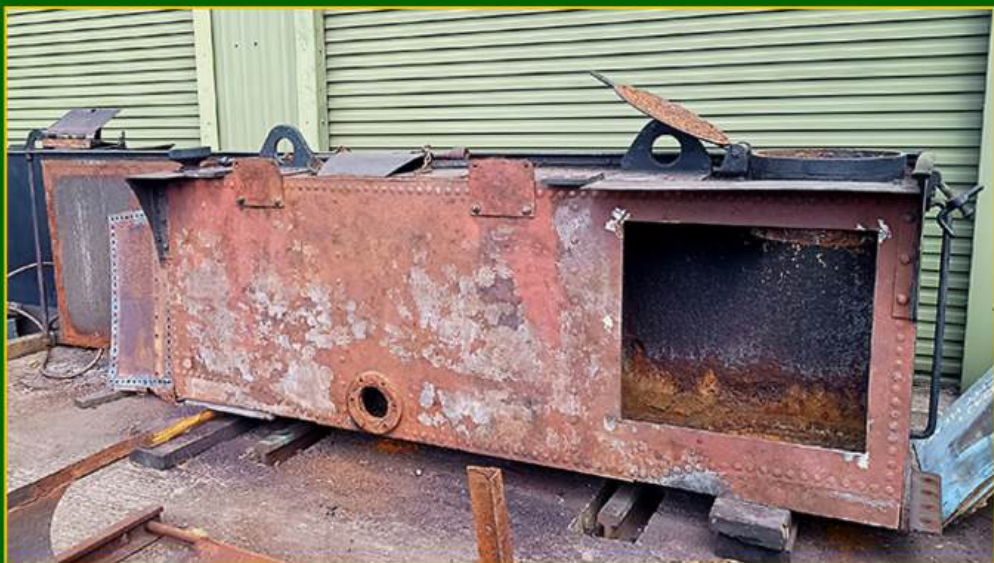
*Wasted tank section cut out waiting for a replacement plate to be welded in.*

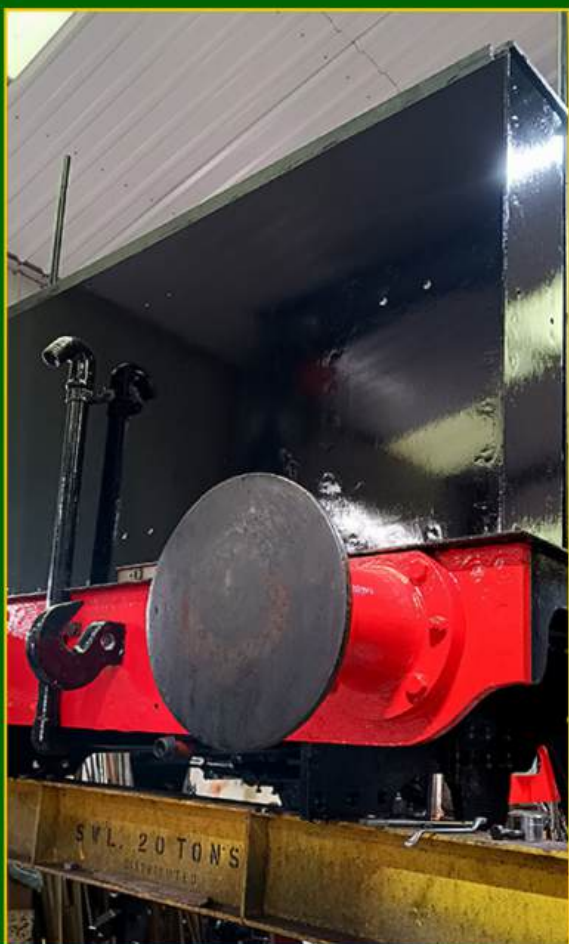
*Cab back paint to top coat.*

The frames have been painted up to top coat and some of the basic pipe work runs have been installed. The new lower sections of the cab are now in place and painted. Preparations are underway for the boring of the cylinders using the ex Eastleigh equipment owned by the Bulleid Society. It is planned to send one of the driving wheel sets to South Devon Railway Engineering so that the journals can be skimmed.
