84030 Rebuild Project

Newsletter No2 September 2021

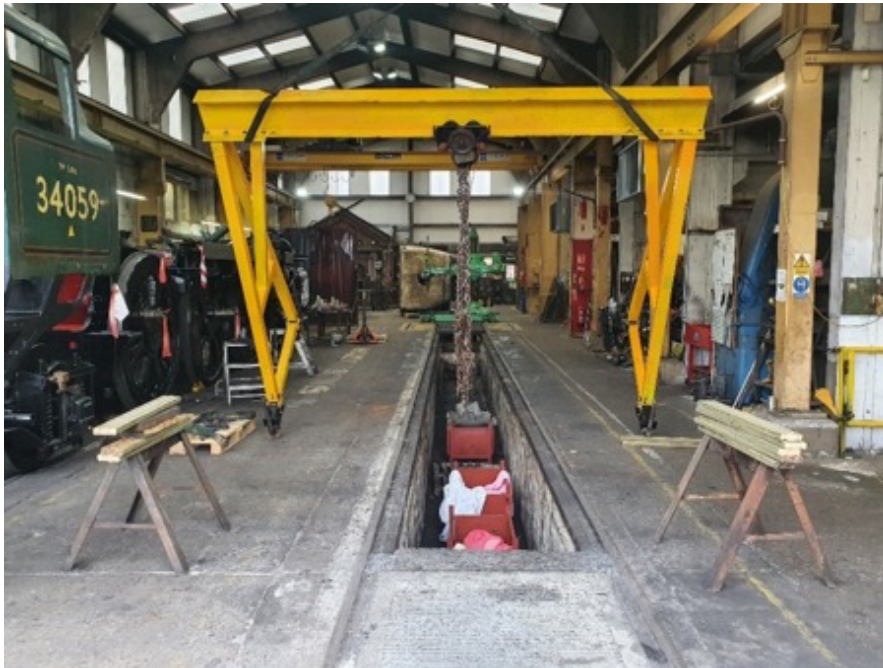
Final stage of assembly with the help of the workshop staff.

Now that we are back after Covid restrictions and to our regular Thursday's the working group have been concentrating on the overhaul of the gantry. Progress has been excellent resulting in it now being complete. We now await the visit of the inspector to issue it a working certificate before the gantry can be put to good use erecting the bunker amongst other lifting duties.

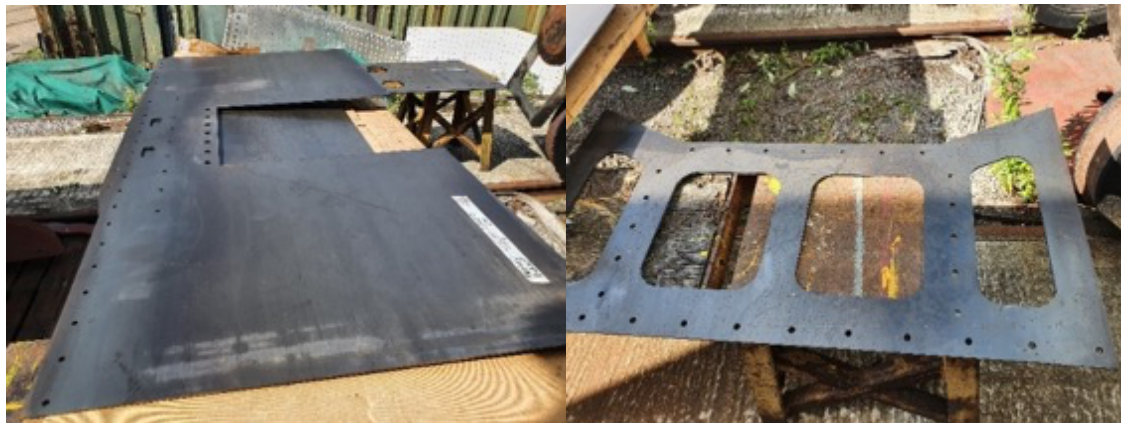
Bunker profiled plates

The first set of profiled plates for the bunker have now been delivered and as the assembly area is open to the elements the first job is to get a coating of protective paint on the plates.

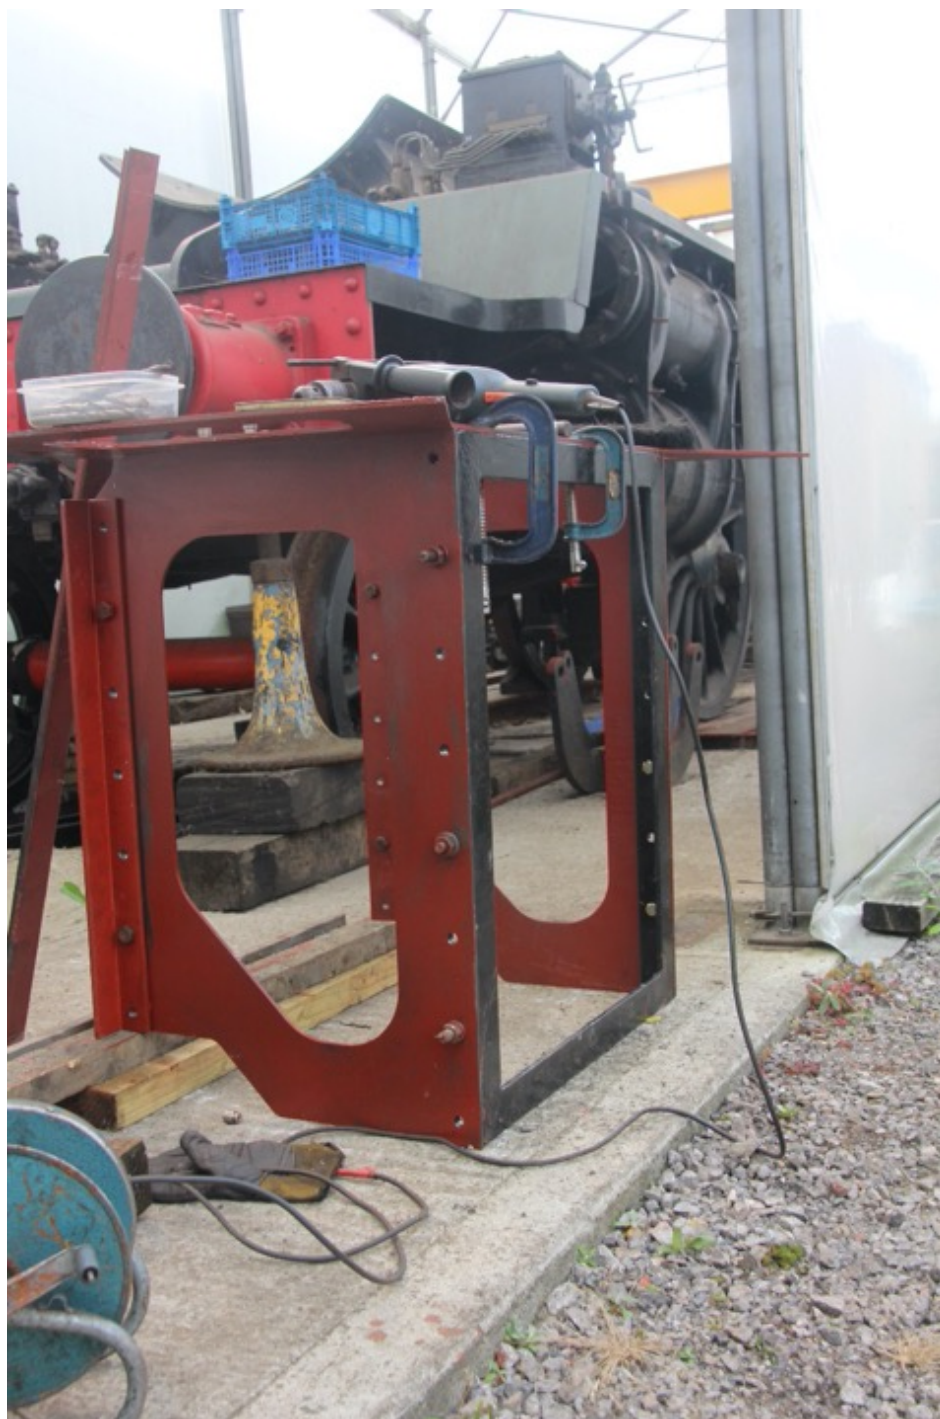
Start of the shovelling plate assembly

Assembly of the bunker has now begun, the first part being the shovelling plate. The profiled holes in the plates used as a template for drilling the angle iron. The assembly is then temporarily bolted together for trial fitting in its final location before drilling/reaming for riveting.
