Infrastructure News

7B points Part 2 - Day Three

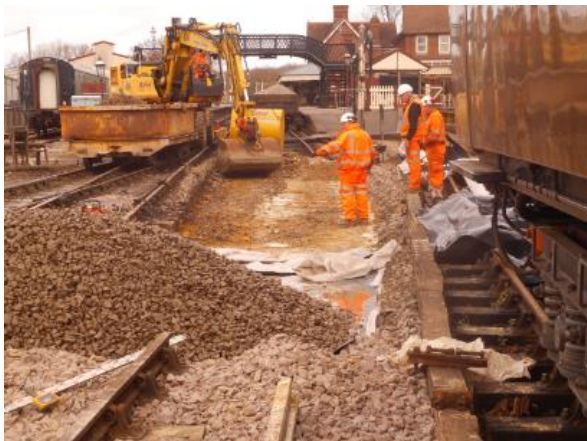
This piece of track keeps sinking into the mud and has had extra ballast and tamping carried out on it several times to keep it stable. Consequently a lot of reusable ballast was scraped off the top after the rails and sleepers had been removed. It was washed with the aid of the water crane and piled up where the crossing nose would be. The track bed was scraped down to the correct level carefully as the existence of the old cast iron pipe was known. One of the joints was found to be leaking which explains why this track bed is always wet. This joint is directly below the west rail with the sleeper did not have much clearance to the pipe as it had sunk so much.

Scraping out the ballast and mud.

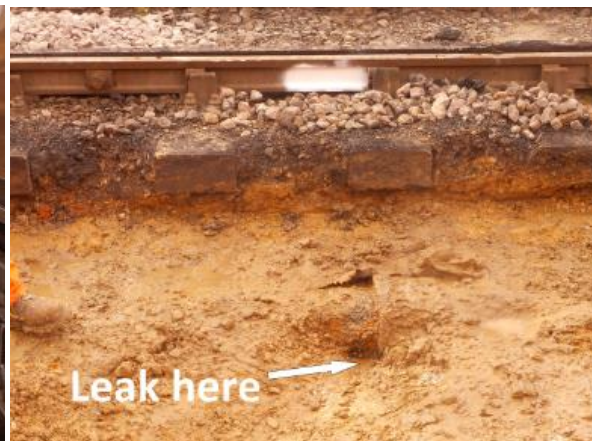
By the end of day two the cause of the drainage problem under the track leading from platform 1 to the points crossing had been discovered. The decision to take out the 60' panel on day one was proven to be a wise one as it unveiled a problem with the main water pipe that runs from the water tower to the water cranes on the two platforms.

Leaking pipe found and marked.

Luckily there is a drainage pipe running past already buried below the track bed, therefore a small drainage trench and pipe were installed it connecting to the leak to the remove the flowing water. The position was marked with a white spray on the adjacent rail. This has shown us the condition of the pipe and we now know that we will have to get a liner installed within the pipe in the near future. This picture also shows how little ballast is under the sleepers on the adjacent track. The sleepers are almost sitting on the bottom of the track bed where there should have been several inches of ballast on top the original chalk membrane. It therefore also show us another dig out task required in the not too distant future.

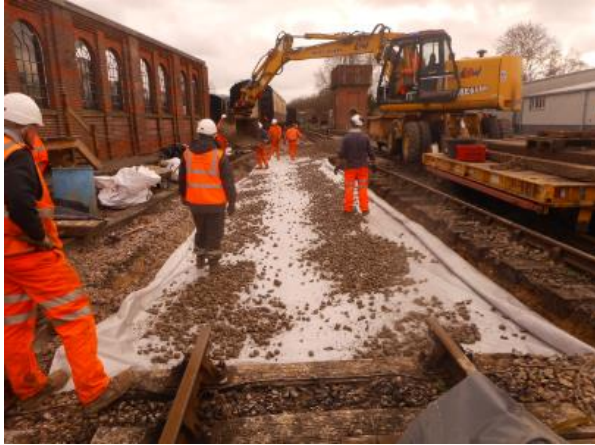
New modern membrane.

All the exposed track bed was covered with our usual sandwich of Terram/plastic DPC/Terram to stop more water soaking into the ground. The washed ballast was spread out and more fresh ballast added up to bottom of sleeper level. It was smoothed and rolled down flat and all the sleepers for the 60' panel laid out. With a bit of **very** clever digger driving, the two bullhead rails were dropped straight in place within the rail chairs in seconds! This normally takes a lot of fiddling, especially on a curve. The panel was then finished off ready for the crossing panel.

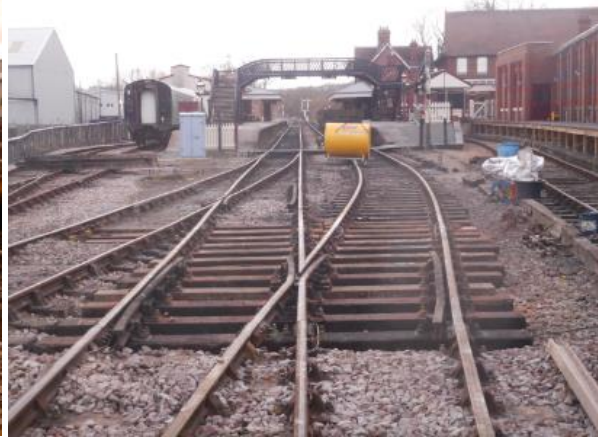
All connected by the end of day three.

The replacement timbers for the crossing were laid out including the 20' timbers which pass under the adjacent track and the rails placed on top. The assortment of fishplates were then put back so that the S&T could get all the track circuits and signal wires reconnected. This left is with over 100 hole to drill in the timbers for the chair screws after carefully aligning and gauging the rails correctly to within 1mm.

By the end of day three it had all been completed with the exception of ballasting and tamping which will probably be done (initially) with a shovel.
