SOUTHERN RAILWAY COACH GROUP

BLUEBELL RAILWAY

Newsletter Issue 2: September 2024

7864: Progress Report #1

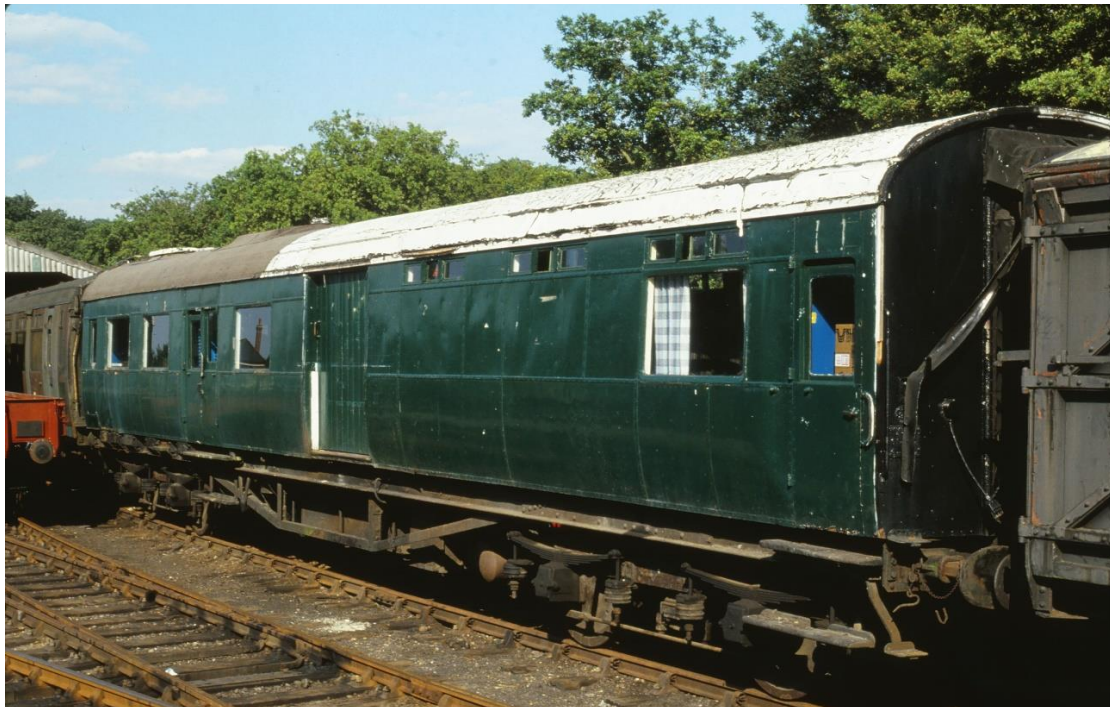
The west side of 7864 in 1982. The large sliding door in the middle of the coach is a Bluebell modification. Considerable further deterioration has occurred during storage since this image was taken. Photo: Tim Robbins

The hole on the west side of the coach that spans four body pillars, where Bluebell previously cut out a section of framing to put in a sliding door, has had replacement pillars and rails made to fill the gap. It has been trial-assembled and looks very impressive.

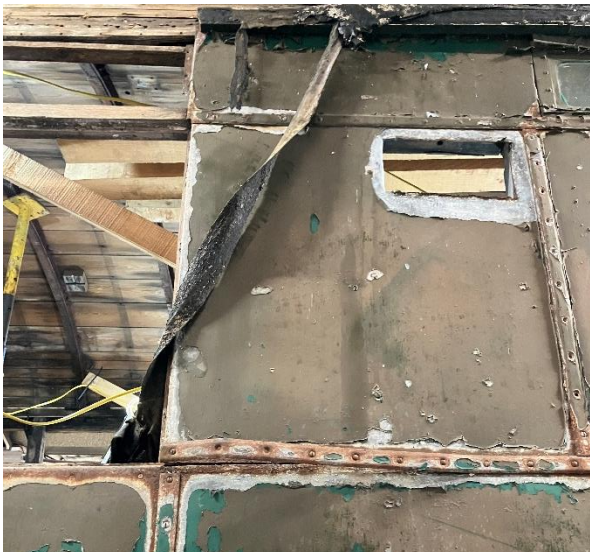
One of the first things to be completed was the removal of the steel sheeting from the bodysides and ends. This is built up of a series of rectangular panels of different sizes, mostly with butt joints that are covered with metal strips screwed to the timber frame. Where a sheet abuts a window, it is returned by about ½" into the opening and screwed on that face, so these screws are concealed by the window frame. The brass top

Steel panelling detail showing the joint cover strips and returns into the window opening. March 2024

50/50 brass and steel, the latter being the worst to get out. All the extant panels have been retained and documented as patterns; none are reusable.

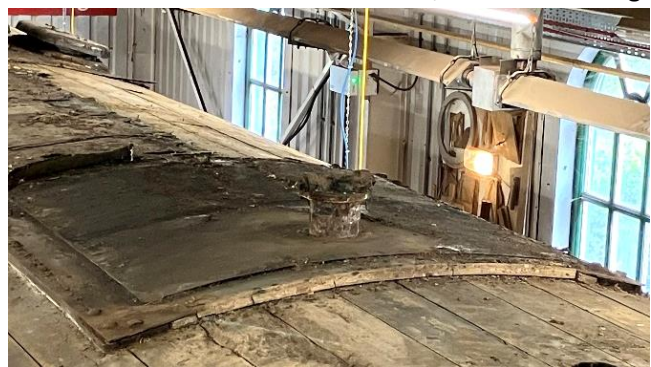
Water tank and (top left of picture) a monsoon vent, still in situ after removing the roof covering and the wooden tank cover. April 2024

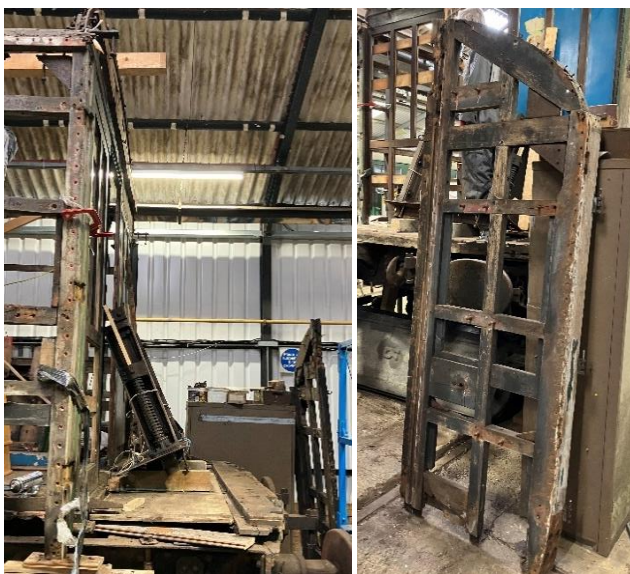
To dismantle the south end, the first step was to free the gangway faceplate from the top and bottom plungers and lower that to the ground. Next, the top plungers, housings and supporting steel framework (which sit in the vestibule ceiling void supported by the end structure and the first partition) were removed. Because of the design, this had to come out as one rather large heavy assembly. Once that was on the ground, it was broken down into its components. What was left was the timber frame, the two halves to left and right of the gangway being linked by a top timber with the joints braced by reinforcing steel L sections; these three frame sections were separated and lifted out of the bottom end timber.

South vestibule after taking down the gangway plungers and end frames; SE end frame. July 2024

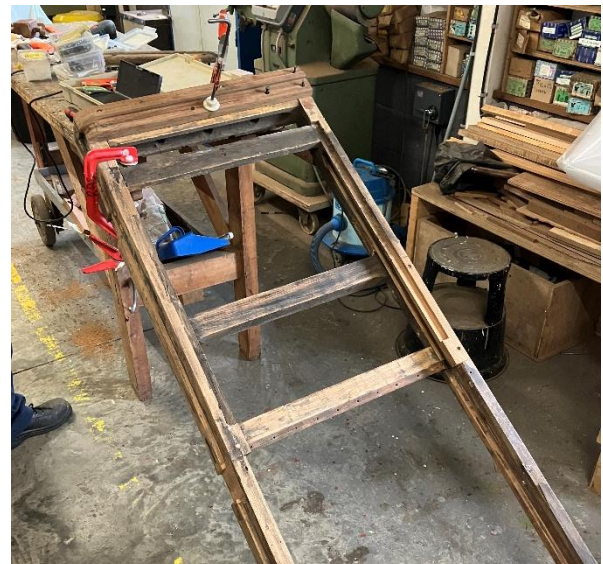
Of the six doors, two for passenger use at the south end and two double doors located somewhat north of the middle on both sides, one had come off previously and was stored inside when 7864 came into the works. The other five have been taken off, and each one stripped of its interior mouldings, droplight, exterior cladding and hinges to leave just a timber frame. We are progressing through the necessary repairs to these frames: two have been worked on so far.

One of the doors from the west side double-door pair under repair; a new bottom moulding has just been added. Sep 2024

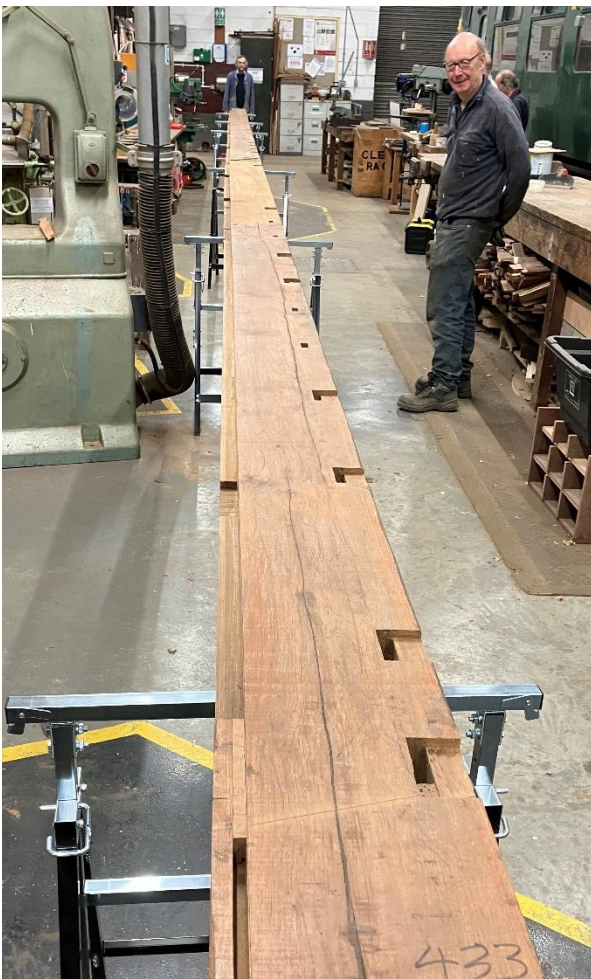
Proceeding in parallel with the dismantling work, major progress has already been made in manufacturing new structural timbers. The first part to be tackled was the new west bottom side. This has been made in five parts lap jointed together with the joints reinforced with bolts. Each piece is now morticed to receive the many body pillars that slot into it. The front edge of the 58' assembly has been chamfered to suit the tumblehome profile of the body and the back edge rebated to receive the floor. The new west side cantrail is also well on the way to being made. All the sections have been produced to length and the joints made, and about half of the morticing has been done.

The four sections of the new west bottom side, set out and temporarily joined so that the chamfer could be applied to the front edge. May 2024

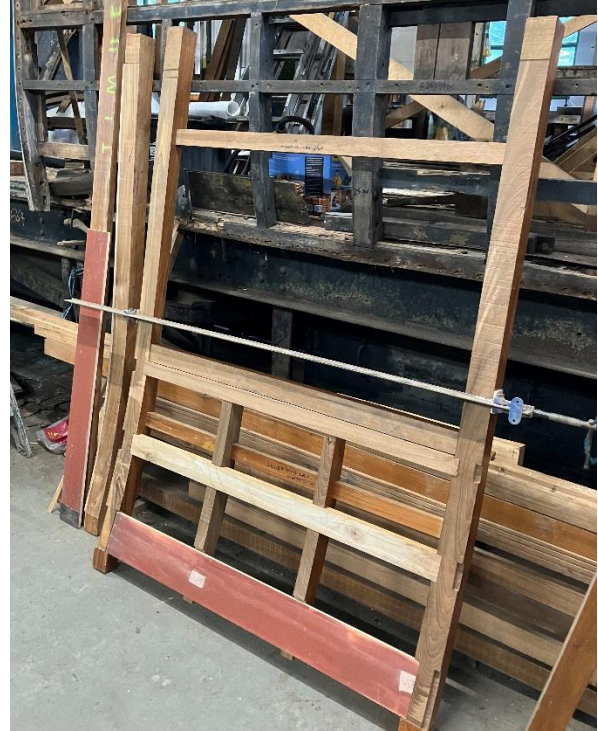
The replacement frame section for the west side; shown is its inner face. Aug 2024

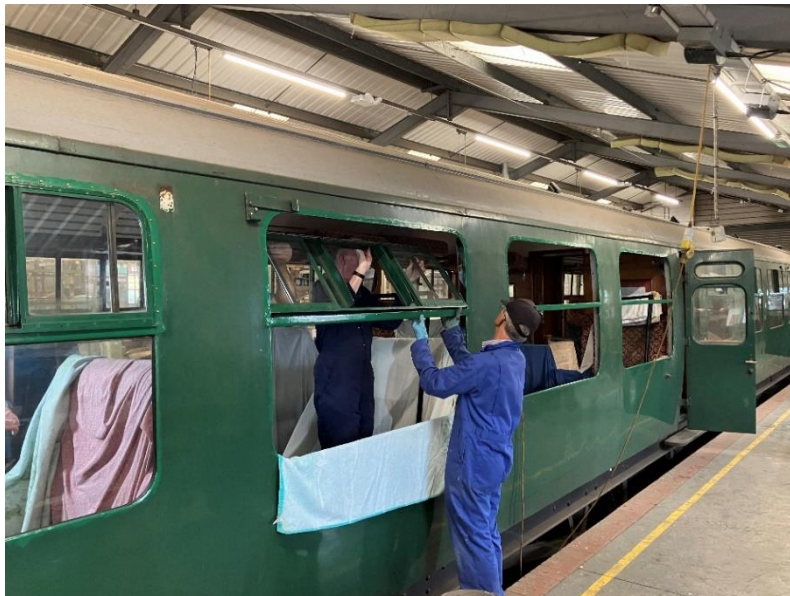
with others in the C&W team. From April to August, the last four sidelights and top lights that had not been previously re-bedded were taken out, the frames de-rusted and painted back up, the glass cleaned and then reinstalled. To do this, the luggage racks had to be taken down and the seats

The second of the four top light assemblies being reinstalled in 1482's northern saloon. July 2024

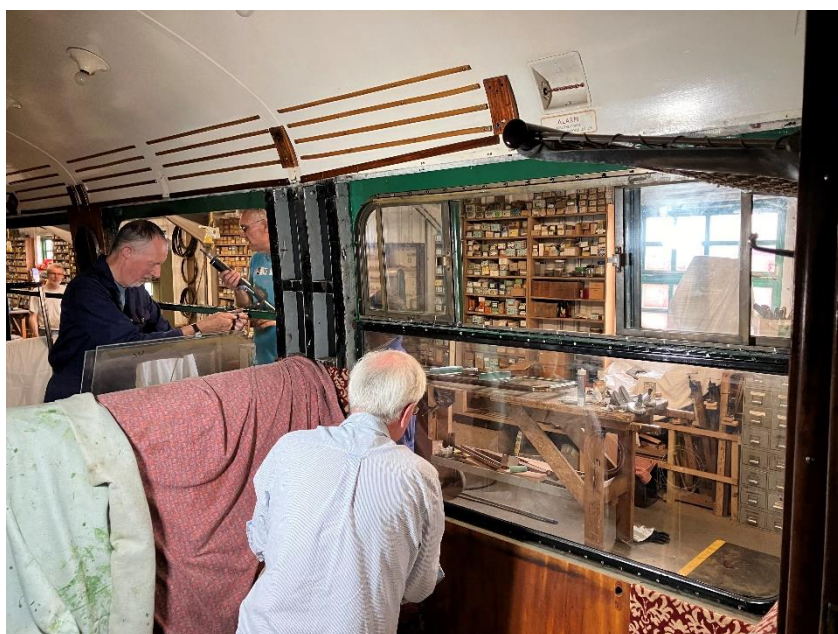
Screwing into place the inner frame for one of 1482's sidelights. July 2024

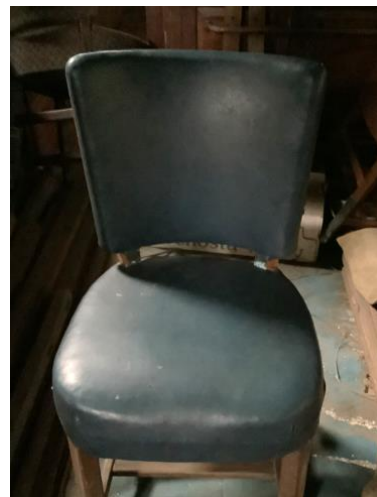
Chair Style 1 - the odd one out

A leather/faux leather finish in a medium to dark blue. There are several chairs in this style. I would be interested to know if this was a BR finish, or something applied by the Bluebell to keep

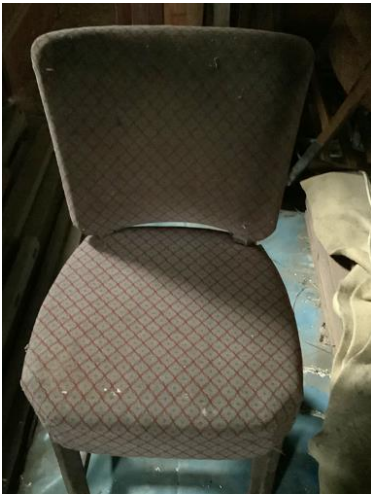
Chair Style 2 - Badly faded but this uncut turquoise fabric with a red diamond pattern with detailing is a common 1950s British Railways moquette.

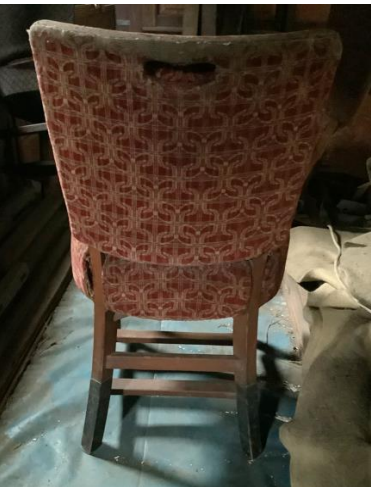
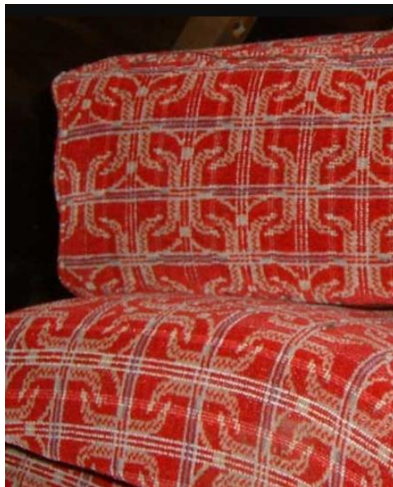
Chair Style 3 - Chain Link. This well-known cut moquette is still produced as a replica moquette and is currently used in Bulleid Semi-Open Brake Third 2526. The photograph shows the rear of the chair and the rebated handle.

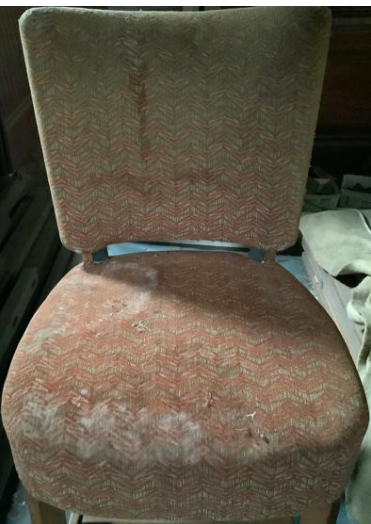
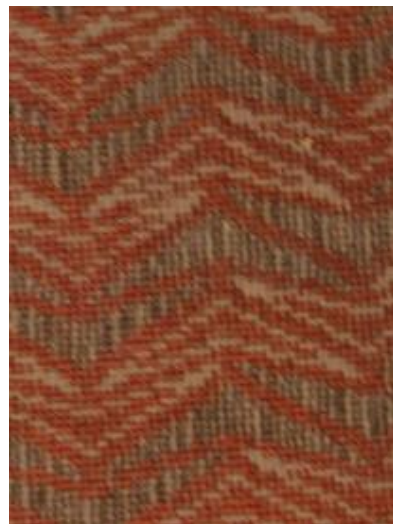
Chair Style 4 –Heavily weathered, this is an uncut fabric of orange arrows on a beige background which was used in 4RES electric stock.
