Q Class 541 Overhaul Progress

By Steve Pilcher and Chris Hunford, Maunsell Locomotive Society

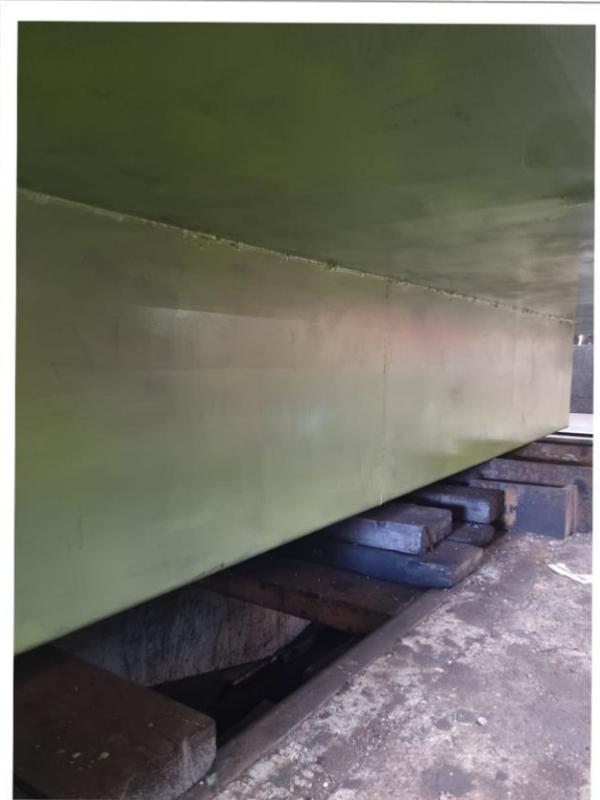
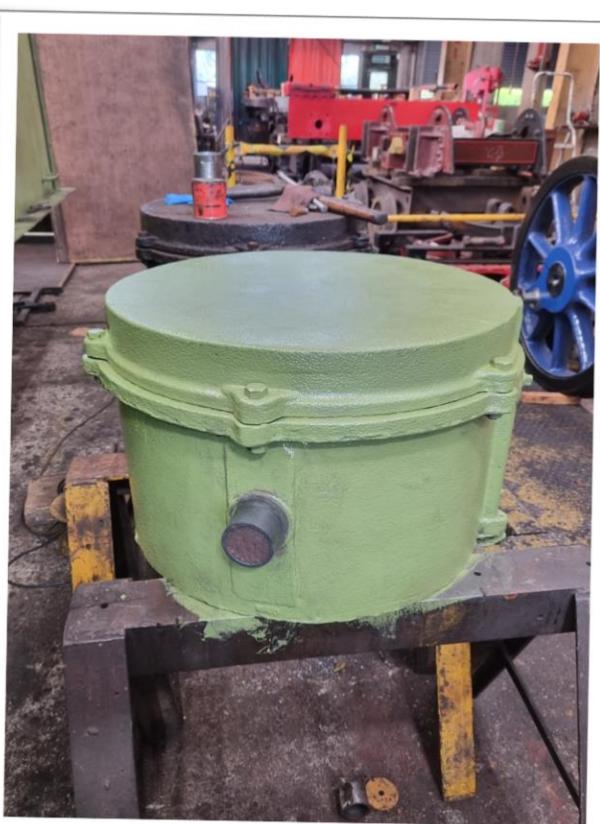
The workshop staff have been busy refurbishing various components of the tender brake gear and workshop and MLS volunteers painted some of the components, including brake cylinders and brake beam. *[Photos right – courtesy Steve Pilcher]*

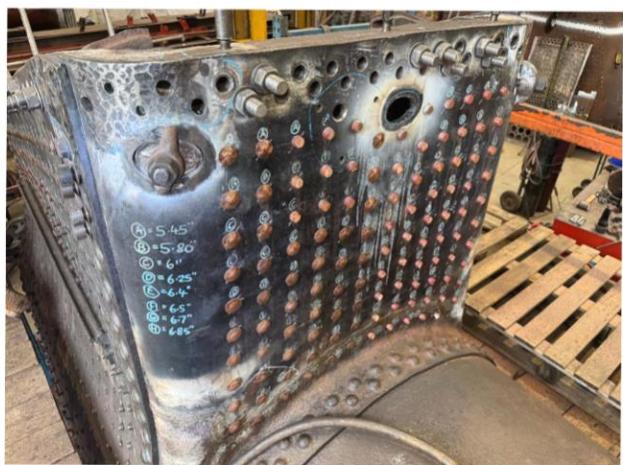
The two front mud hole doors have been repaired and fitted to the corresponding openings in the throat plate. Middle door is being worked on at the minute. *[Photo below – courtesy Leaky Finders]*
