260 yards of track replaced in one day!

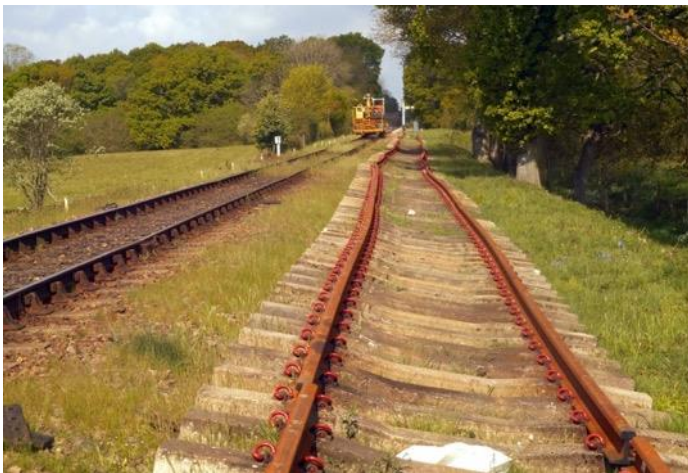
New panels placed beside the existing track.

The relay, the third this year, continued the replacement of old track on Freshfield Bank. Only another 13 panels are now required to reach the curve at the bottom of the bank and complete the entire straight top to bottom. Due to the replacement being straight, the panels were made up in advance at Horsted Keynes and transported to site in preparation for the replacement.

Preparation was started several weeks beforehand with posts being knocked into the ground every 10 yards with a reference nail in them exactly two meters from the running face of the west rail. This was to provide a reference to aid alignment when putting the new track in place. 26 new rails (one complete lorry load) 364 good second hand concrete sleepers with 728 rubber pads and 1456 clips were fully assembled into the 13 panels in

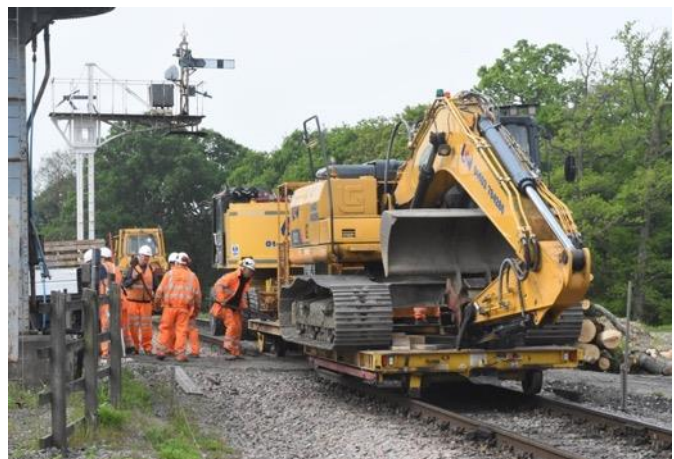
Loading up for the “engineering train”.

First thing Monday morning, a train was made up with everything needed for the job including the laser bull dozer, a big road-railer, two trollies, one with the big 22-ton digger which only just

fitted under the bridges, and one with all the tools, a man-cage with the men inside, tea, coffee and a Portaloo!

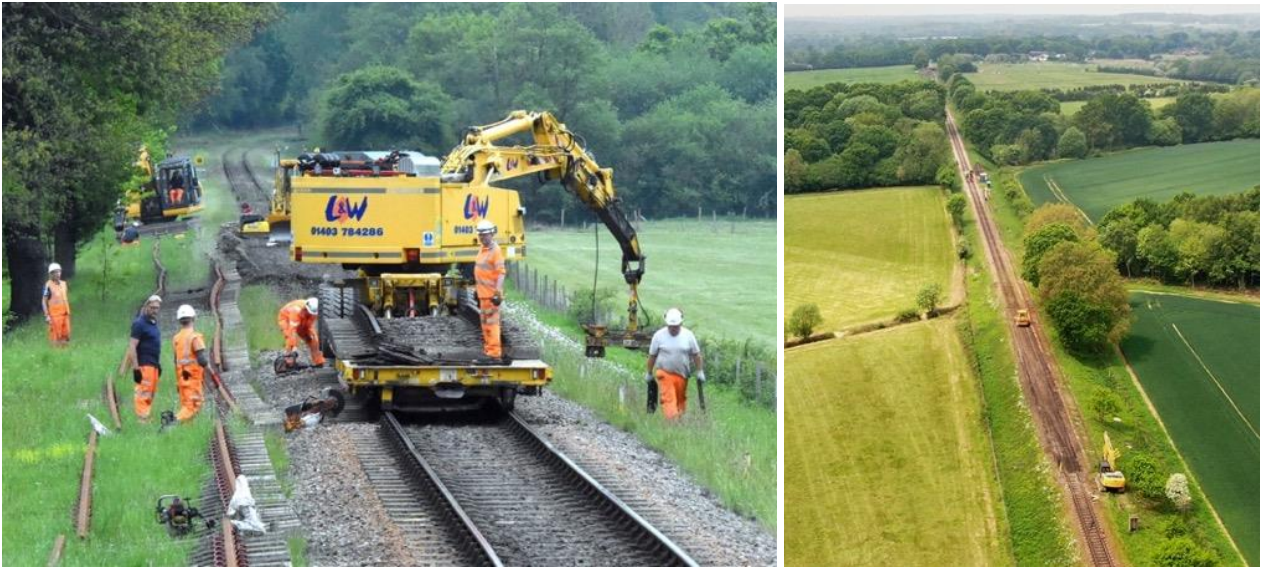
Track removal viewed from the signal post and from John Harwood's drone.

On site, the first thing (after putting on the kettle) was to undo all the fishplates, lift the panels out and stack them out of the way. With the laser set up to the correct gradient, the bulldozer could then doze the existing ballast to the correct gradient and levels, removing a known dip in the track bed in the process. This was followed by the Triple Wacker which flattened the old ballast to a smooth compacted bed ready for the new track.

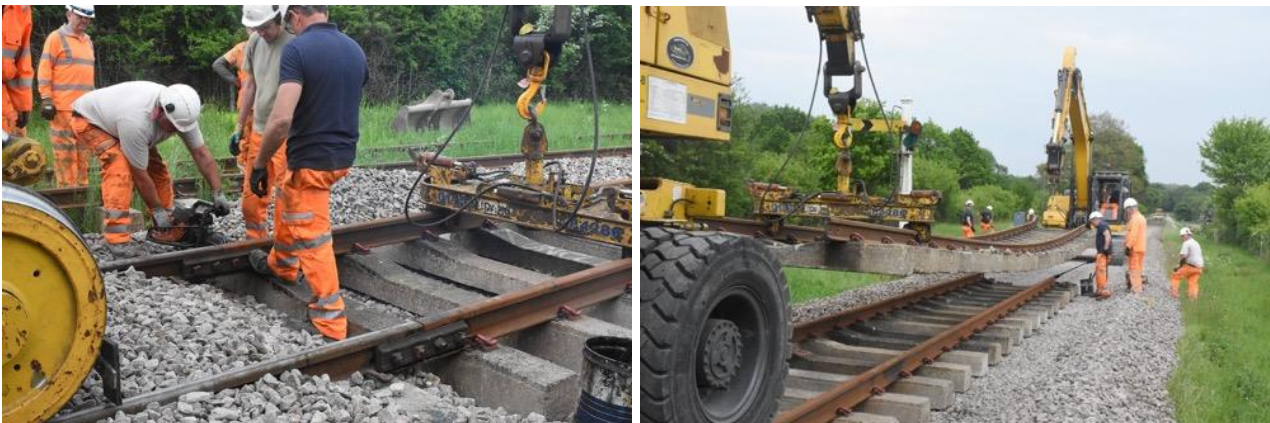
First panel being bolted in place.

Next panel being lifted in.

Putting in the new panels was like clipping Lego together. Eight of the pre-prepared panels went in in just one hour. The road-railer picked up one end and the 22-ton caterpillar-tracked digger lifted the other. The road-railer lifted the end up to the existing track which was then bolted on with the heavy-duty fish plates and the other end was lowered onto the line marked in from the reference posts. The road-railer could then move onto the panel and repeat the process for the next panel.

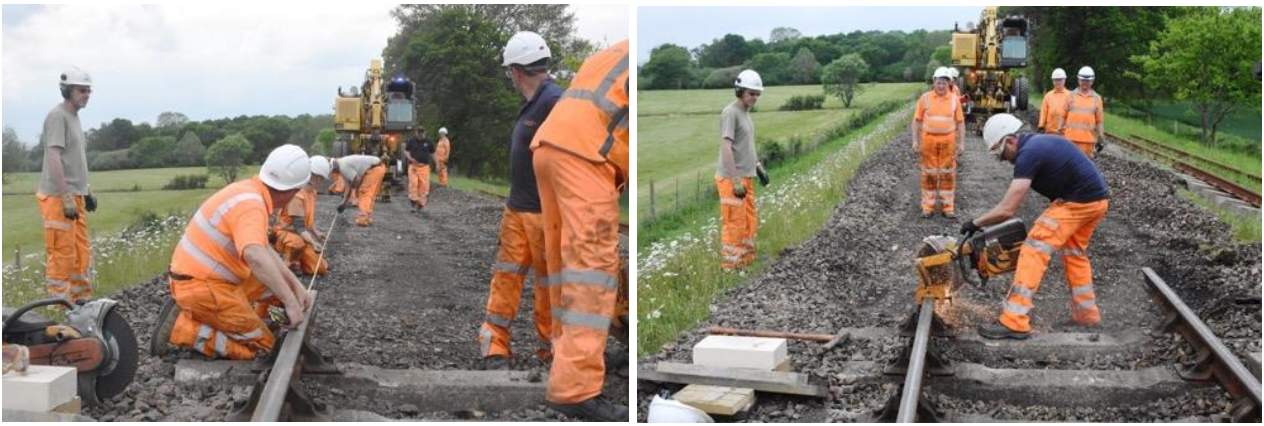
Measuring and cutting in the last panel.

For the last panel, the gap was purposely left a little short of 60 feet so that it could be cut to length exactly allowing for the gaps in the joints. The rail is exactly 60 feet long 18,288 mm but measured 18,291 mm on our tape. (Few tapes are that accurate or very expensive.) This is why the 260 yard was removed one sleeper bed short so that the last panel can be measured and cut in exactly including allowing for all the joints over the whole length of the job.

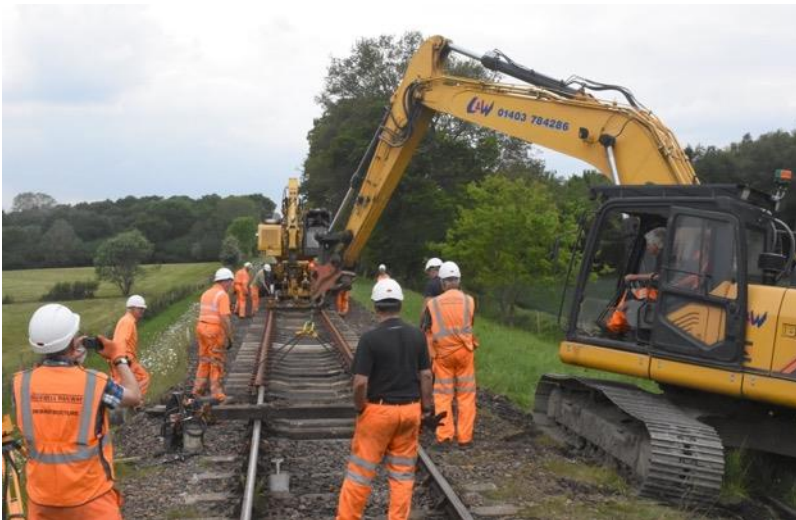
It fits!

Bolting up the last panel ended the first day's work. With no ballast added or tamping done trains could not pass over the formation but the road-railer passing over it demonstrated that a train could do so safely if necessary.

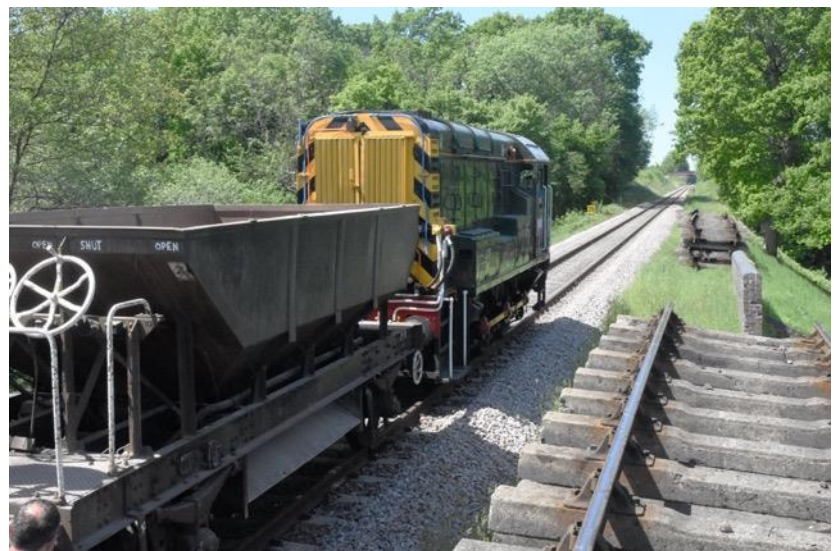
Diesel hauled ballast hoppers.

Day two saw over 200 tons of fresh ballast dropped onto the new track and ploughed evenly to beyond the ends of the sleepers.

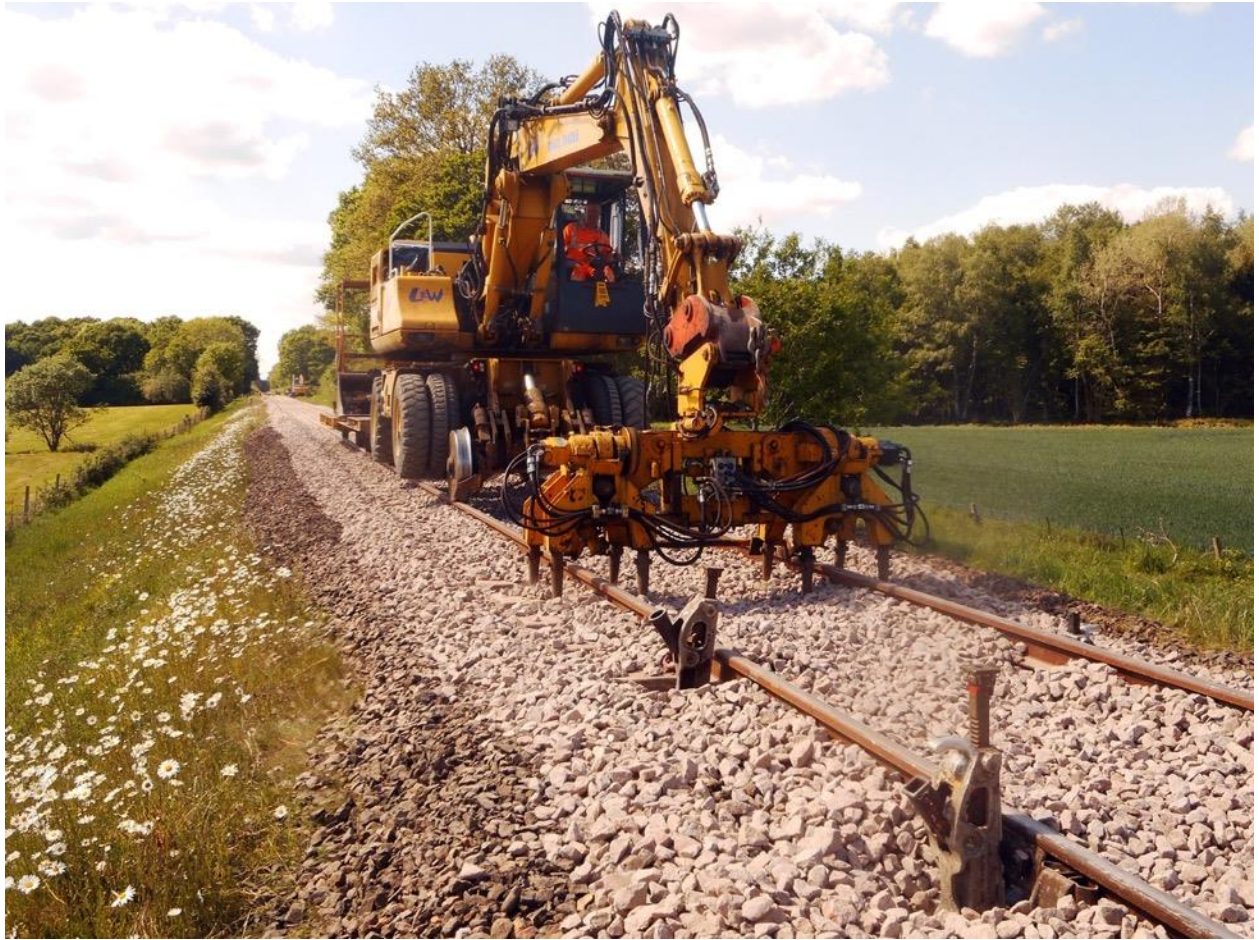
Tamping the ends of the job.

The ends of the job were lifted level on jacks and then tamped with a tamping bank on the road-railer. It is

at the job ends where voids can appear under the sleepers because the bulldozer cannot doze right up to the very end cleanly. This then ensured that the track was safe to run trains over it at reduced speed until the full tamp is carried out although it was actually smooth enough for full line speed. However the temporary speed limit (TSR) will stay in place until the track is fully tamped about two weeks later.

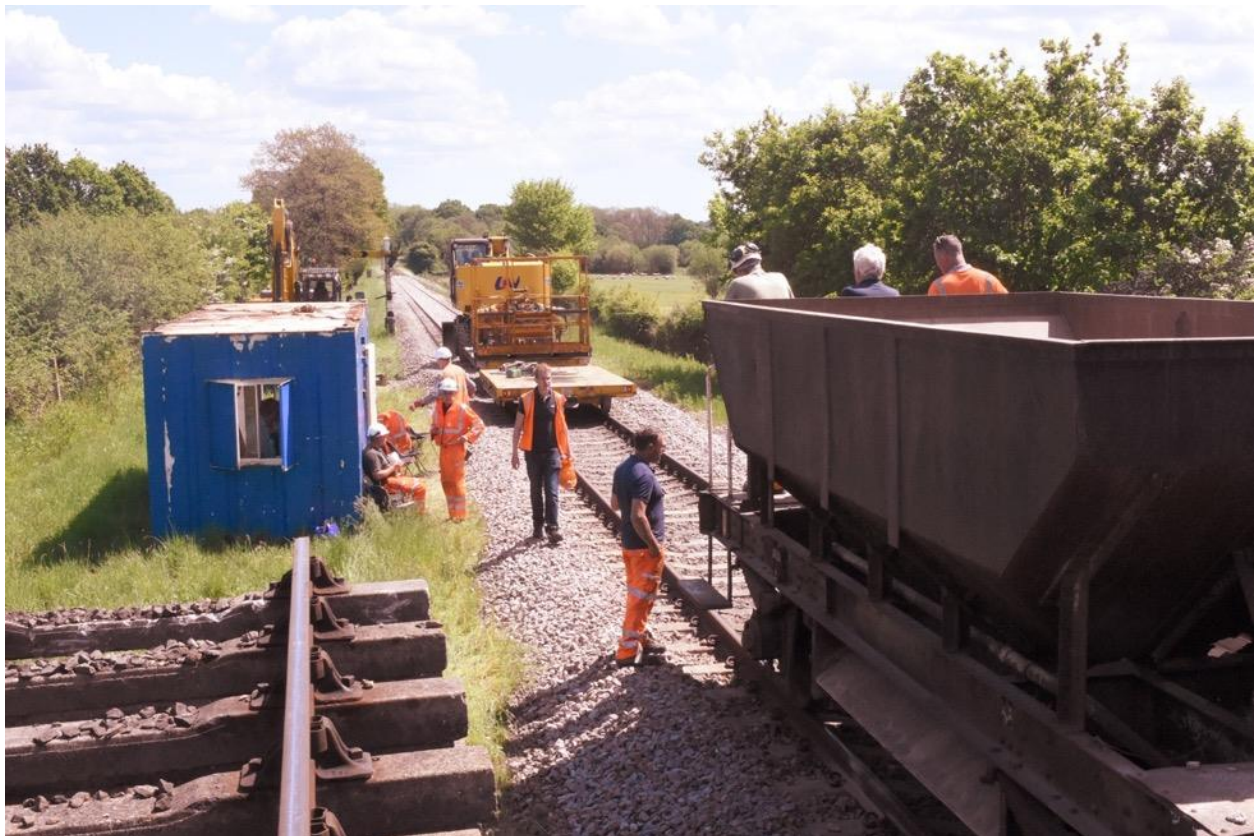
Standing back and admiring the finished job

The last thing to be done was to correct the alignment. The track followed the original line within 2-3 inches over the whole length despite only being dropped in by the digger road-railer combination. Final correction was done by the big digger standing beside the track with the jib on the rail pushing or pulling it sideways as instructed by a person visually sitting along the rail and calling out which way to push it around. A very good alignment was achieved with clever operation of the digger all set for the service trains the following morning.
